FCA CARIBBEAN WARRANTY BULLETIN

NO: ID-22-23
DATE: August 23, 2023

SUBJECT: 2017 – 2023 (Current) Chrysler Pacifica (RU) and 2013 – 2016 Chrysler Town & Country/ 2013 – 2020 Dodge Caravan (RT) - Corrosion – **Complete Hood Panel Warranty Claim Simplification (Rev. B)**

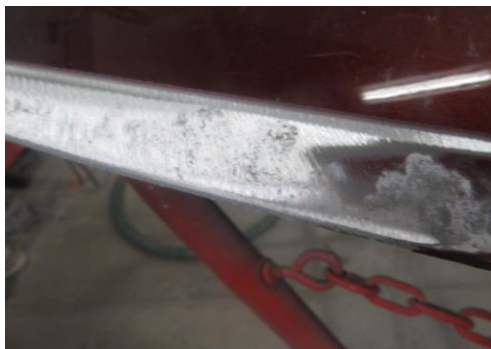
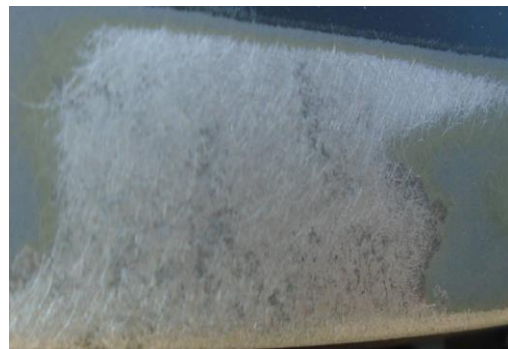
1. Perforation/ Pitting found during the sanding process (Fig. 1)

Perforation/Pitting Found After Sanding Examples (Fig. 1)

Note: If pitting is found during the sanding process, please use LOP 23-75-21-01 for up to 0.5 hours in conjunction with the 23-85 replacement LOP.

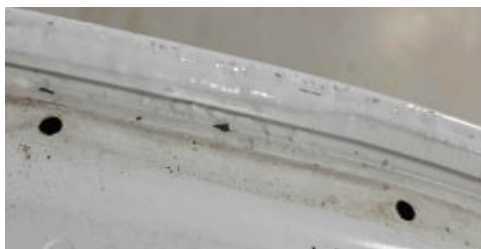
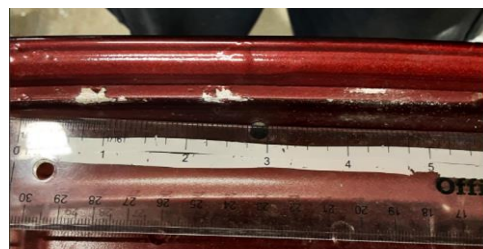
2. Corrosion found on the Hem Flange on the underside of the hood (Fig. 2)

Hem Flange Area Examples (Fig. 2)

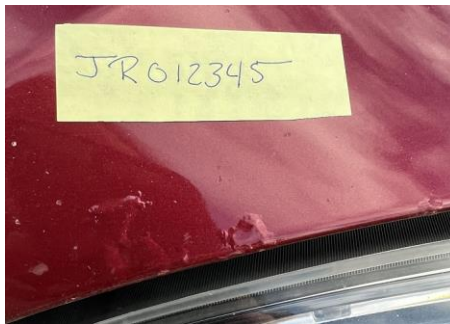
VIN Example (Fig. 3)

Photos to support corrosion repairs or replacement must show the VIN in the photo. The VIN can be written on masking tape, on the panel with a grease pen or a sticky note. The important part is that the VIN **MUST** be seen near the corrosion area to support the repair as seen in (Fig 3).
