(Revision 7) August 2023

Dealer Service Instructions for:

Emissions Recall U90 Catalyst Efficiency

About 935,668 of the above vehicles may exceed tailpipe emission standards due to a loss of catalyst CO/NOx conversion efficiency resulting from the catalyst operating at high temperatures.

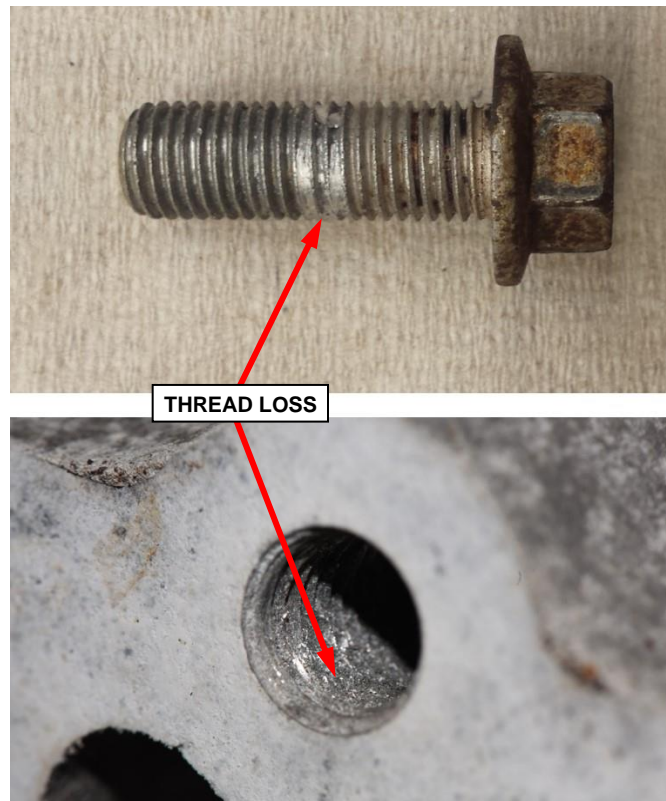
Figure 18 – Inspect for Thread Loss

NOTE: Pay attention to the bolts for signs of thread loss or bolt breakage as they are removed and note which hole they came from (Figure 18).

26. Inspect the bolts and bolt holes for any signs of thread loss then **DISCARD** the bolts (Figure 18).

- If bolt holes do not show signs of thread loss, proceed to **Step 29**.
- If bolt holes show signs of thread loss, continue with **Step 27**.
- If a bolt is broken off in the hole, proceed to **Step 28**.

27. If thread loss is suspected, use compressed air to remove any debris from the suspect bolt hole. With the old maniverter and gasket still in place on the engine head, install a **NEW** exhaust manifold bolt in the suspect hole and tighten the bolt to 34 N·m (25 ft. lbs.) to determine if proper torque can be achieved.

- If the bolt is able to be tightened to 34 N·m (25 ft. lbs.), no further action is required. Remove the bolt and proceed to **Step 29**.
 - If the bolt hole threads are stripped allowing the bolt to rotate, unable to achieve proper torque, remove the bolt and continue with **Step 28**.

28. For stripped hole(s) or broken bolt(s), submit a collateral damage claim to obtain authorization for installing a helicoil in the damaged hole(s). Remove the maniverter and gasket following **Steps 29 - 31**. Then use the special tool **2073500090 - Kit, Cylinder Head Thread Repair - 2.4L MAIR** to perform the helicoil thread repair operation by following the service instructions published in **DealerCONNECT / Service Library / Engine, 2.4L Multiair / Standard Procedure / Exhaust Manifold Fastener Hole Repair**. After the damaged bolt hole(s) have been repaired with helicoil(s), proceed with **Step 32**.
