CUSTOMER SATISFACTION NOTIFICATION

Serpentine Belt Squeal

Reference: 47A

2022 - 2023 (RU) Chrysler Pacifica/Voyager

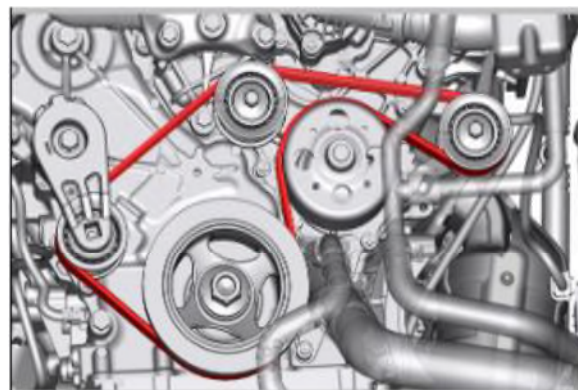
Figure 7 – Serpentine Belt Routing

NOTE: When installing the serpentine accessory drive belt, the belt MUST be routed correctly. If not, the engine may overheat due to the water pump rotating in the wrong direction.

8. Remove the serpentine belt and **DISCARD**.
9. Install the left idler pulley onto the front center of the engine and tighten the bolt to 24N·m (18Ft. Lbs.) (Figure 7).

10. Install the right idler pulley bracket onto the right side of the engine and tighten the bolt to 24N·m (18Ft. Lbs.) (Figure 7).
11. Install the right-side idler pulley and tighten the bolt to 24N·m (18Ft. Lbs.) (Figure 7).

12. Install the **NEW** belt tensioner and tighten the bolt to 55N·m (41Ft. Lbs.).
13. Route the **NEW** serpentine belt around all the pulleys except the idler pulley (Figure 7).

14. Rotate the belt tensioner until it contacts its stop position. Route the serpentine belt around the idler and slowly let the tensioner relax. Make sure the belt is properly seated onto all pulleys (Figure 7).
15. Measuring from the AC compressor electrical connector install the High Voltage (HV) wire harness clips on to the harness and attach them to the idler pulley bracket as shown in (Figure 8).
