CUSTOMER SATISFACTION NOTIFICATION

Serpentine Belt Squeal

Reference: 47A

2022 – 2023 (RU) Chrysler Pacifica/Voyager

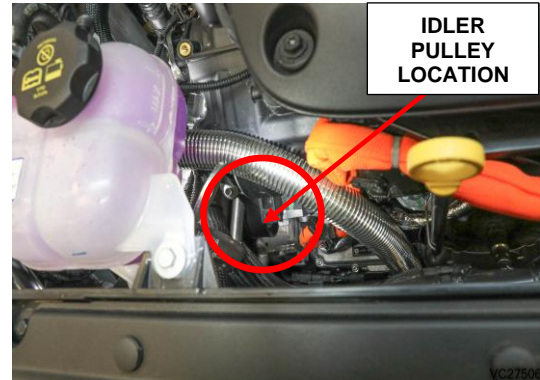
Figure 1 – Idler Pulley

1. Open the hood and support.
2. Visually look for the presence of the idler pulley (Figure 1).
3. Is the idler pulley present?
 - **YES:** No further action required, return the vehicle to the customer, claim inspection LOP.
 - **NO:** Proceed to Service Procedure below.

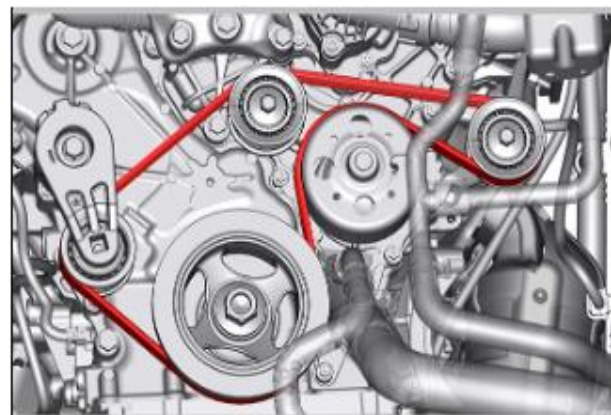
Figure 8 – Serpentine Belt Routing

NOTE: When installing the serpentine accessory drive belt, the belt MUST be routed correctly. If not, the engine may overheat due to the water pump rotating in the wrong direction.

8. Remove the serpentine belt and **DISCARD**.
9. Install the left idler pulley onto the front center of the engine and tighten the bolt to 24N·m (18Ft. Lbs.) (Figure 8).

10. Install the right idler pulley bracket onto the right side of the engine and tighten the bolt to 24N·m (18Ft. Lbs.) (Figure 8).
11. Install the right-side idler pulley and tighten the bolt to 24N·m (18Ft. Lbs.) (Figure 8).

12. Install the **NEW** belt tensioner and tighten the bolt to 55N·m (41Ft. Lbs.).
13. Route the **NEW** serpentine belt around all the pulleys except the idler pulley (Figure 8).
