| REFERENCE: | TSB: 08-186-23 REV. A GROUP 08 - Electrical | Date: | August 16, 2023 | REVISION: | 08-186-23 |
| VEHICLES AFFECTED: | **2023 (DT) RAM 1500 Pickup This bulletin applies to vehicles built on and after January 01, 2023 (MDH 0101XX) and on and before July 31, 2023 (MDH 0731XX) equipped with Brazil - Connectivity (Sales Code RTP).** 2023 (DS) RAM 1500 Pickup 2023 (DJ) RAM 2500 Pickup 2023 (D2) RAM 3500 Pickup This bulletin applies to vehicles built on and after February 04, 2023 (MDH 0204XX) and on and before July 05, 2023 (MDH 0705XX) equipped with Brazil - Connectivity (Sales Code RTP). | | | MARKET APPLICABILITY: <input type="checkbox"/> NA <input type="checkbox"/> MEA <input checked="" type="checkbox"/> SA <input type="checkbox"/> IAP <input type="checkbox"/> EE <input type="checkbox"/> CH | |
| CUSTOMER SYMPTOM: | Customers may experience the following: <ul style="list-style-type: none"> • Wi-Fi Hotspot does not work. | | | | |
| CAUSE: | Sales Code missed | | | | |

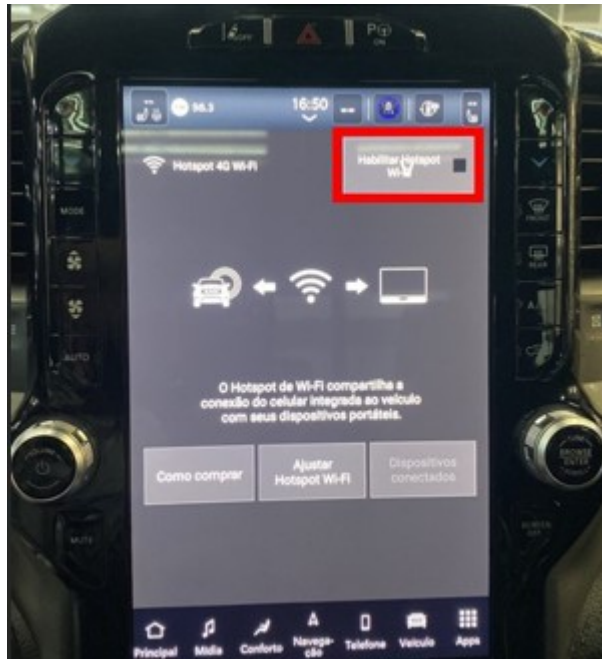
1. Validate that the vehicle has a problem by trying to check the Wi-Fi option: (Fig. 1) , (Fig. 2) .

Fig. 1
Wi-Fi Off

- YES>>> This bulletin is complete. Use Inspect LOP (18-19-02-HR) to close this active RSU.
- NO>>> Proceed to [Step 1](#) of the Repair Procedure.

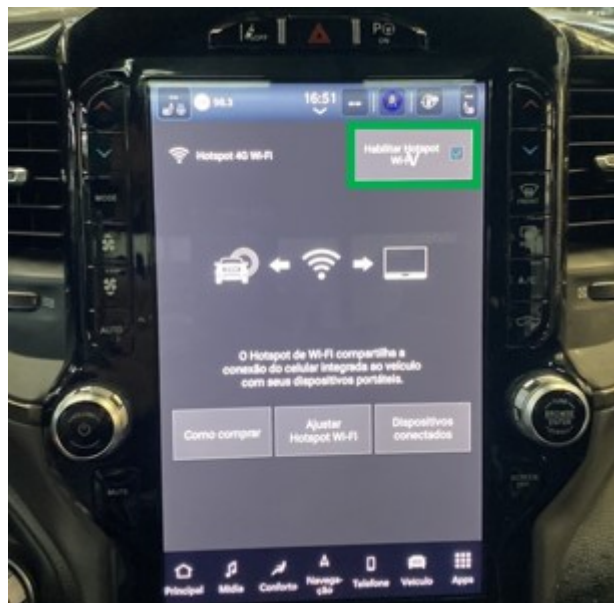
Fig. 2
Wi-Fi On

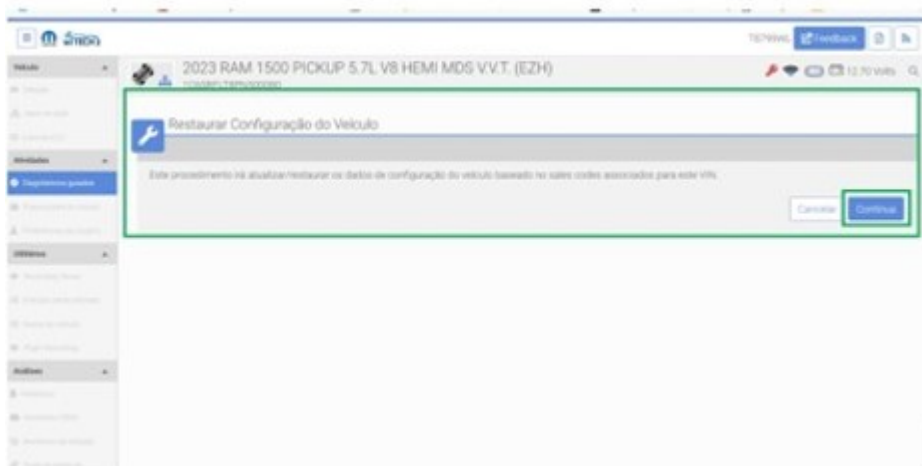
Fig. 3
Restore Vehicle Configuration

1. Using wiTECH, restore vehicle configuration. This routine is available under the 'Guided Diagnostics' tab found on the home, 'Vehicle View' page of wiTECH (Fig. 3) .
