Technical Service Bulletin (TSB)
Easy Entry Seat Function not Locking in Place

REFERENCE:	TSB: 23-088-23 GROUP 23 - Body	Date:	August 3, 2023	REVISION:	-
VEHICLES AFFECTED:	2023 (JL) Jeep Wrangler This bulletin applies to vehicles built on and after August 19, 2022 (MDH 0819XX) and on or before September 17, 2022 (MDH 0917XX) that are Two Door vehicles (Sales Code 5ZS).	MARKET APPLICABILITY:			
		<input checked="" type="checkbox"/> NA		<input checked="" type="checkbox"/> MEA	
		<input checked="" type="checkbox"/> SA		<input checked="" type="checkbox"/> IAP	
		<input checked="" type="checkbox"/> EE		<input type="checkbox"/> CH	
CUSTOMER SYMPTOM:	One or both front seats can become stuck in the tumble forward or easy entry position. If this occurs on the driver side, the vehicle will not be able to be driven (the seat back will be locked forward).				
CAUSE:	Fore/Aft seat position returns (memory stone) is breaking.

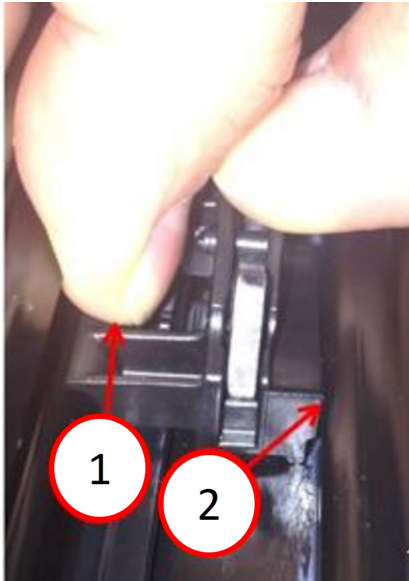
Fig. 2

Seat Position Return Installation

- 1 - Push This Side Of The Seat Position Return
 - 2 - Side Of The Seat Position Return To Insert Into The Track First
-

2. Insert the new seat position return corrugated side first, into the seat track (Fig. 2) .

3. Install the new seat position return by placing one finger on the peak and a second finger on the open cavity side, pushing the seat position return straight down into the seat track (Fig. 2) .
4. Take one finger and press on the rear raised metal insert (Fig. 3) and slide the seat position return fore and aft in the seat track.

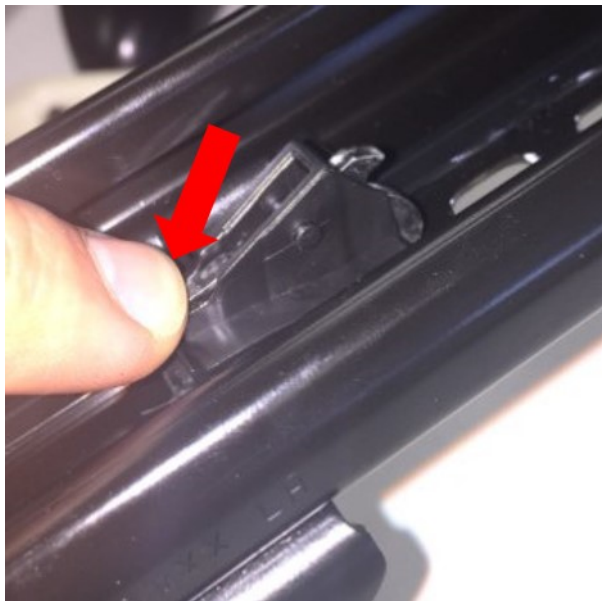
Fig. 3

Sliding Seat Position Return In Track
