REFERENCE:	TSB: 08-195-23 GROUP 08 - Electrical	Date:	August 4, 2023	REVISION:	08-172-22
VEHICLES AFFECTED:	2022 - **2023** (RU) Chrysler Pacifica This bulletin applies to vehicles built on or after November 17, 2021 (MDH 1117XX) and on or before **April 17, 2023 (MDH 0417XX)** equipped with Seat Back Video Screens (Sales Code RHH).	MARKET APPLICABILITY:			
CUSTOMER SYMPTOM:	Customer may experience the following: <ul style="list-style-type: none"> **Rear seat entertainment DVD Blue-ray® inoperative.** Right and/or Left rear seat entertainment screen(s) goes blank. 				
CAUSE:	Rear entertainment display screens software.

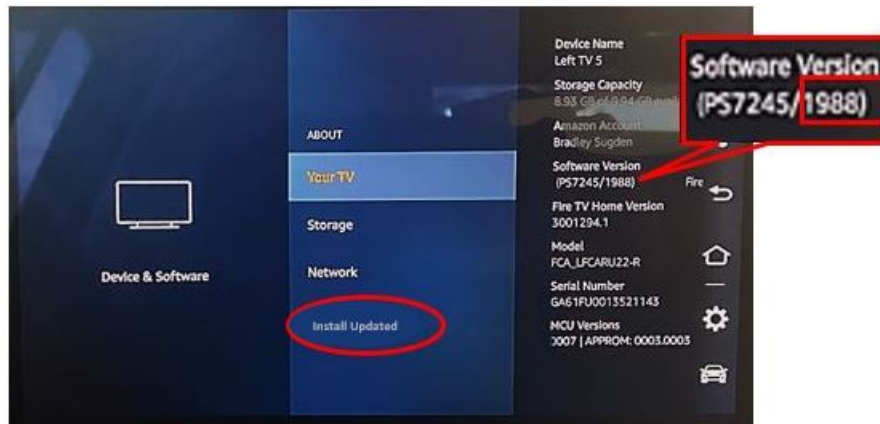
Fig. 5
Software Version Display (Generic Figure Displayed)

8. On the right side of the display screens (**both screens need to be checked**) under “Software Version”, is the software at or above ****3434****? (Fig. 5) .
- YES>>> This bulletin has been completed. Use inspect LOP (**18-19-91-AA**) to close the active RSU.
 - NO>>> Proceed to [Step 9](#).

9. Select “Install Updates” to start the software update. (Fig. 5) .
10. It will download the software first and then it will install software.
11. Once complete select reboot is needed.
12. Turn off the ignition, open and close the door and let all modules go to sleep. Make sure the scan tool is not connected to the vehicle.
13. Turn the vehicle back on and verify the software version is at ****3434**** or higher, after updates (Fig. 5) .
14. After the updates are completed, log out of the account. This will insure the account info and password is deleted.
