REFERENCE:	TSB: 14-007-23 GROUP 14 - Fuel System	Date:	August 11, 2023	REVISION:	-
VEHICLES AFFECTED:	2023 (WL) Jeep Grand Cherokee This bulletin applies to vehicles built on or before November 26, 2022 (MDH 1126XX) equipped with 3.6L V6 VVT Engine Upgrade 1 (Sales Code ERC).		MARKET APPLICABILITY: <input checked="" type="checkbox"/> NA <input type="checkbox"/> MEA <input type="checkbox"/> SA <input type="checkbox"/> IAP <input type="checkbox"/> EE <input type="checkbox"/> CH		
CUSTOMER SYMPTOM:	Customers may experience a Malfunction Indicator Lamp (MIL) illumination. Upon further investigation the technician may find the following DTC has been set: <ul style="list-style-type: none"> P0456 - EVAP System Small Leak. 				
CAUSE:	Fuel tank filler tube

This bulletin involves inspecting and if necessary replacing the fuel filler tube.

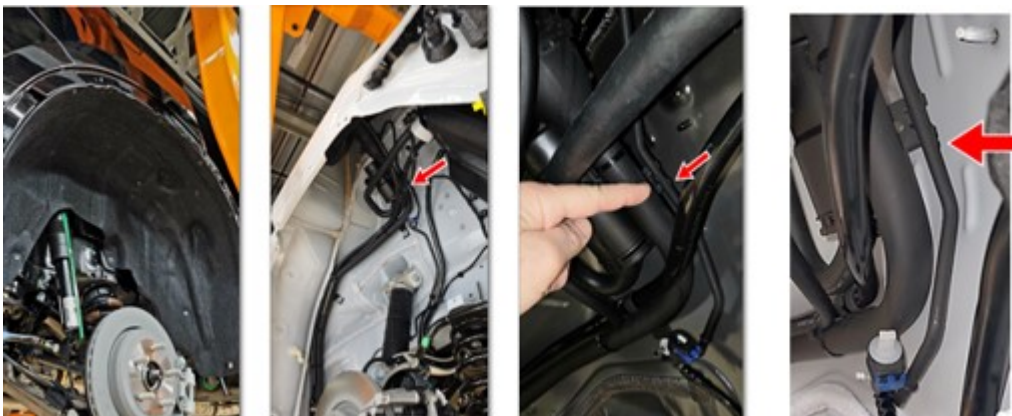
1. Test the EVAP system for leaks. Refer to the detailed service procedures available in DealerCONNECT> Service Library under: Service Info> 25 - Emissions Control / Evaporative Emissions / Diagnosis and Testing> EVAP Emissions PCM Diagnostics - Non Turbo.
2. Visually inspect the fuel vapor recirculation tube for damage at bracket weld bead location ([Fig. 1](#)) or ([Fig. 2](#)) .
3. Is a leak detected?
 - YES>>> Proceed to [Step 4](#).
 - NO>>> This bulletin has been completed, use inspect LOP (14-60-15-9G) to close the active RSU.

Fig. 1
Fuel Tank Filler Tube Weld Location

4. Replace fuel filler tube. Refer to the detailed service procedures available in DealerCONNECT/Service Library under: Service Info>14 - Fuel System / Fuel Delivery, Gas / Tube, Fuel Tank Filler / Removal/ Installation.
5. Perform Small Leak Verification Test (SLVT) - P0456 - EVAP System Small Leak again. Refer to the detailed service procedures available in DealerCONNECT> Service Library under: Service Info>section 04- Vehicle Quick Reference.
Did the SLVT test pass?
 - YES>>> This bulletin has been completed, use repair LOP (14-60-15-9H) to close the active RSU.
 - NO>>> Further normal diagnosis will be needed.

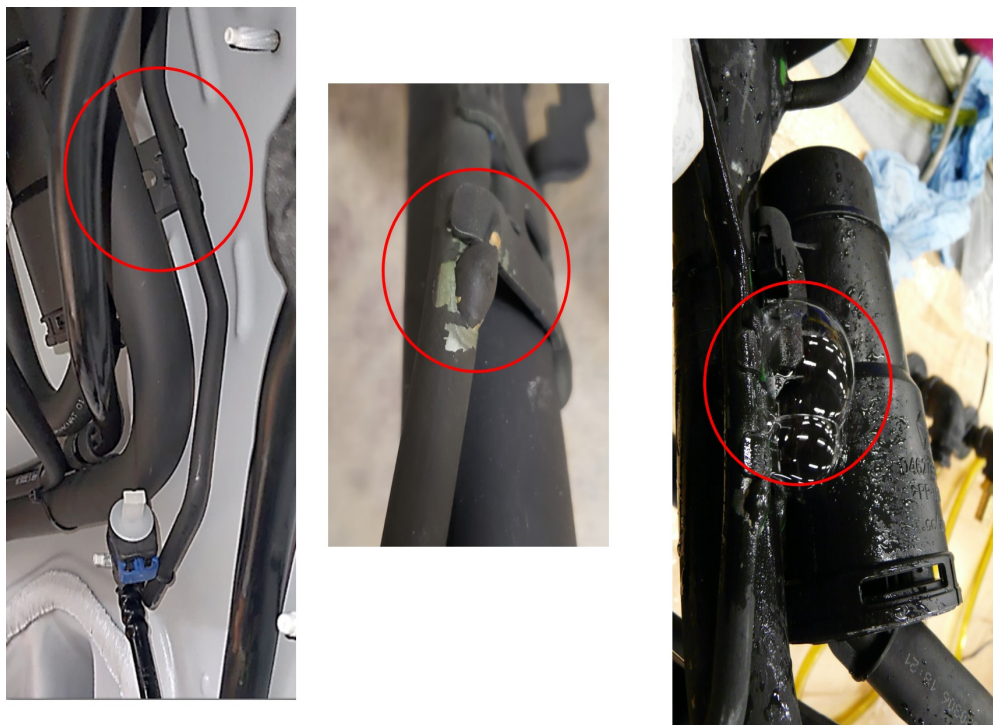
Fig. 2
Leak Locations
