<b>REFERENCE:</b>	<b>TSB:</b> 08-055-23 REV. A <b>GROUP</b> 08 - Electrical	<b>Date:</b>	August 11, 2023	<b>REVISION:</b>	08-055-23
<b>VEHICLES AFFECTED:</b>	<p><b>2022 - 2023 (WL) Jeep Grand Cherokee</b> <b>2022 - 2023 (WS) Grand Wagoneer/Wagoneer</b> <b>This bulletin applies to vehicles built on or before **October 14, 2022 (MDH 1014XX)** equipped with one of the following radios:</b></p> <ul style="list-style-type: none"> <li>• Uconnect 5 W 8.4" Display (Sales Codes UBF or UEF).</li> <li>• Uconnect 5 NAV W 8.4" Display (Sales Codes UBL or UEL).</li> <li>• Uconnect 5 NAV W 10.1" Display (Sales Codes UBN or UEN).</li> <li>• Uconnect 5 NAV W 12" Display (Sales Codes UBQ or UEQ).</li> </ul>			<p><b>MARKET APPLICABILITY:</b></p> <p><input checked="" type="checkbox"/> NA <span style="float:right"><input type="checkbox"/> MEA</span></p> <p><input type="checkbox"/> SA <span style="float:right"><input type="checkbox"/> IAP</span></p> <p><input type="checkbox"/> EE <span style="float:right"><input type="checkbox"/> CH</span></p>

<b>CAUSE:</b>	Radio Software

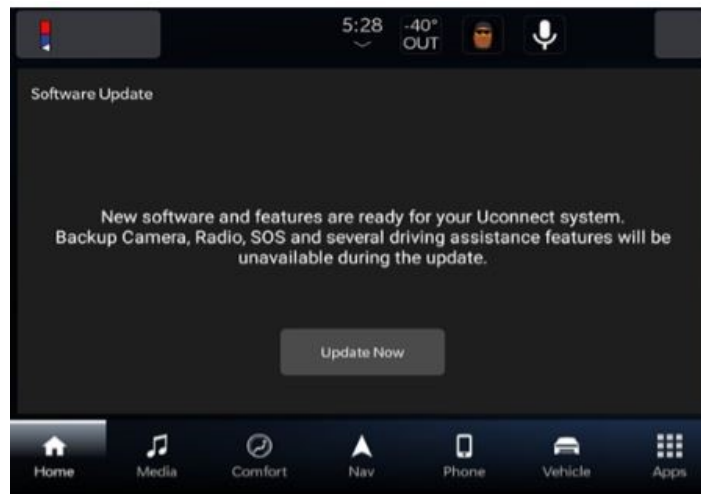
**Fig. 1**

**Software Acceptance Screen**

1. The vehicle needs to be in 'Park'. The ignition needs to be in the off position.
2. If the customer selects “Update Now” (Fig. 1) they can shut off the vehicle and leave. The update will be completed automatically.
