Technical Service Bulletin (TSB)

No Crank and Horn Continually Going Off

REFERENCE:	TSB: 08-197-23 GROUP 08 - Electrical	Date:	August 11, 2023	REVISION:	-
VEHICLES AFFECTED:	2023 (WL) Jeep Grand Cherokee This bulletin applies to vehicles built on or before March 02, 2023 (MDH 0302XX).	MARKET APPLICABILITY:			
		<input checked="" type="checkbox"/> NA		<input checked="" type="checkbox"/> MEA	
		<input type="checkbox"/> SA		<input checked="" type="checkbox"/> IAP	
		<input type="checkbox"/> EE		<input type="checkbox"/> CH	
CUSTOMER SYMPTOM:	Customers may experience one or more of the following: <ul style="list-style-type: none"> • Engine no crank/no start. • Horn continually sounds off. 				
CAUSE:	Coolant spilled onto the center of the (under hood) Power Distribution Center (PDC).

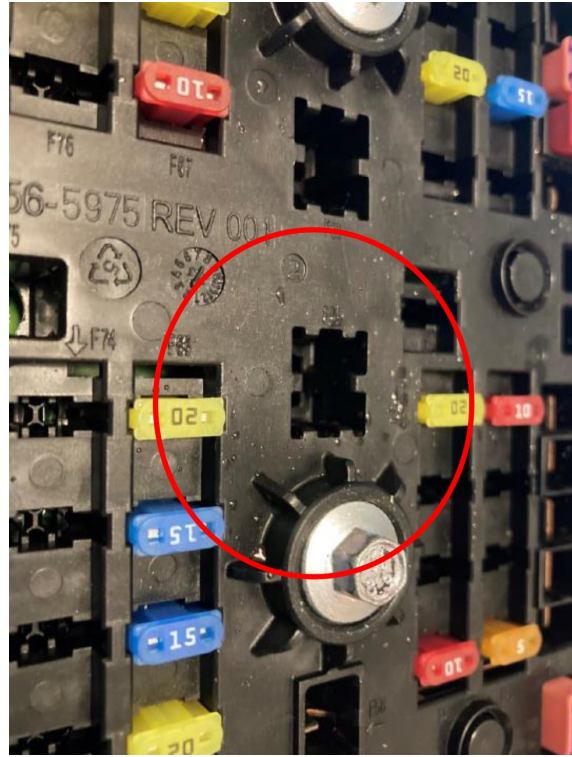
1. Open the hood.
2. Remove the PDC cover.
3. Either visually inspect the PDC for traces of engine coolant (Fig. 1) on or near the fuses, if this is not possible the use of an ultraviolet light may be used.

Fig. 1
Traces Of Engine Coolant On PDC

4. Are traces of engine coolant found on, or near the PDC fuses (Fig. 1) ?
 - YES >>> Proceed to [Step 1](#) of the Repair Procedure.
 - NO >>> bulletin has been completed. Use inspect LOP (08-89-02-95) to close the active RSU.

1. Replace the PDC. Refer to the detailed service procedures available in DealerCONNECT> Service Library under: Service Info>08 - Electrical / 8W - Power Distribution / Center, Power Distribution (PDC) / Removal and Installation.
2. Clear any DTCs that may have been set.
