REFERENCE:	TSB: 08-148-23 REV. B GROUP 08 - Electrical	Date:	August 23, 2023	REVISION:	08-148-23 REV. A
VEHICLES AFFECTED:	2023 (GG) Dodge Hornet This bulletin applies to vehicles built on or before May 30, 2023 (MDH 0530XX).	MARKET APPLICABILITY:			
		<input checked="" type="checkbox"/> NA <input type="checkbox"/> MEA <input type="checkbox"/> SA <input type="checkbox"/> IAP <input type="checkbox"/> EE <input type="checkbox"/> CH			
CUSTOMER SYMPTOM:	<p>Customers may experience a Malfunction Indicator Lamp (MIL) illumination. Upon further investigation the technician may find that the following DTC has been set:</p> <ul style="list-style-type: none"> • C0529-00 - Steering Angle Sensor Module Missing Calibration - No Subtype Information. <p>The customer may experience the following:</p> <ul style="list-style-type: none"> • During a key OFF and ON action, rotating the steering wheel without any power assist, the Malfunction Indicator Light (MIL) ON will be activated due to a loss of calibration of the steering angle sensor. After turning the steering wheel lock to lock, the MIL will be switched off.

CAUSE:	EPS software

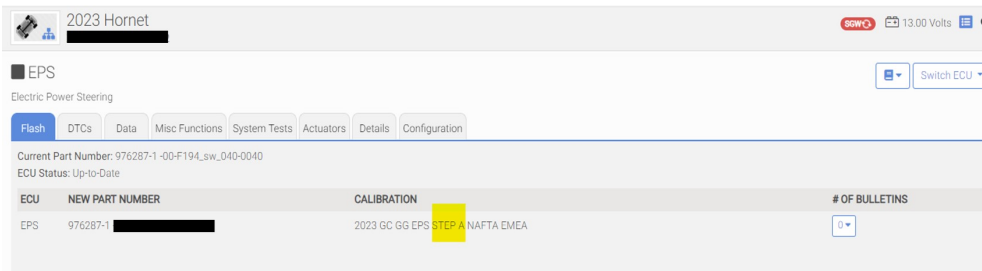
Fig. 1

CAUTION! Multiple step flashes up to three may be necessary and are required to completely update this EPS these must be performed in order starting with STEP A or B and ending with Step C, be sure to follow wiTECH accordingly (Fig. 1) .

Example of wiTECH Step Flashes

3. **Select the appropriate software per wiTECH (Step A, B or C) either Step A or B must be done first in order and end with Step C when finished.**
4. Reprogram the EPS module with the latest software. Detailed instructions for flashing control modules using the wiTECH Diagnostic Application are available by selecting the application's "HELP" tab.
5. Wait 2 minutes after the EPS flash has been completed.
6. To perform an EPS reset with wiTECH - Go to the Guided Diagnostics menu --> Select Reset ECU --> Select "EPS" from the list of modules --> Click "Continue" at the bottom of the page then follow the wiTECH prompts.
