REFERENCE:	TSB: 08-198-23 GROUP 08 - Electrical	Date:	August 17, 2023	REVISION:	—
VEHICLES AFFECTED:	2021 - 2022 (RU) Chrysler Pacifica This bulletin applies to vehicles equipped with Global Telematics Box Module (Sales Code RDG).			MARKET APPLICABILITY: <input checked="" type="checkbox"/> NA <input type="checkbox"/> MEA <input type="checkbox"/> SA <input type="checkbox"/> IAP <input type="checkbox"/> EE <input type="checkbox"/> CH	
CUSTOMER SYMPTOM:	<p>Customers may experience one or more of the following:</p> <ul style="list-style-type: none"> • Uconnect Box requires service message at start up. • Losing Wi-Fi Hotspot streaming connection: internet data is not reliable. • User is unable to setup the Charge schedule/Climate schedule events in Uconnect App (TBM is sending failure message). • LED blinking on overhead console after ignition cycle. <p>These conditions do not affect the rear view camera display.</p>

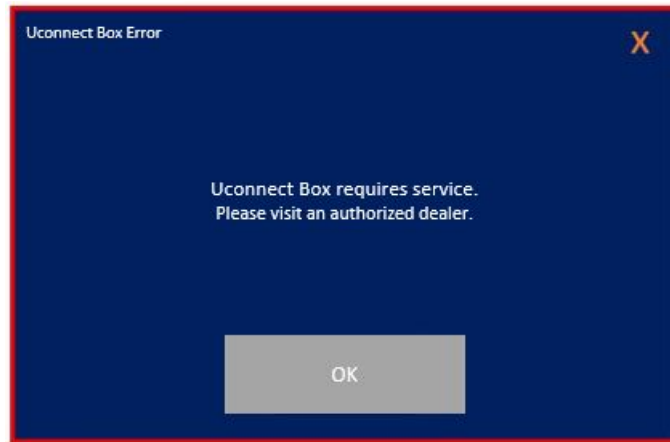
CAUSE:	TBM Software

Fig. 1
Uconnect Box Error Message

Message display on the radio screen, “Uconnect Box requires service. Please visit an authorized dealer.” (Fig. 1) , with no active or stored Diagnostic Trouble Codes (DTCs) set by the TBM.

This bulletin provides information regarding the latest Firmware Over The Air (FOTA) update and provides the service technician an overview of the steps a customer will need to take to complete the update. The TBM software will be updated from 4.29c to 4.36.

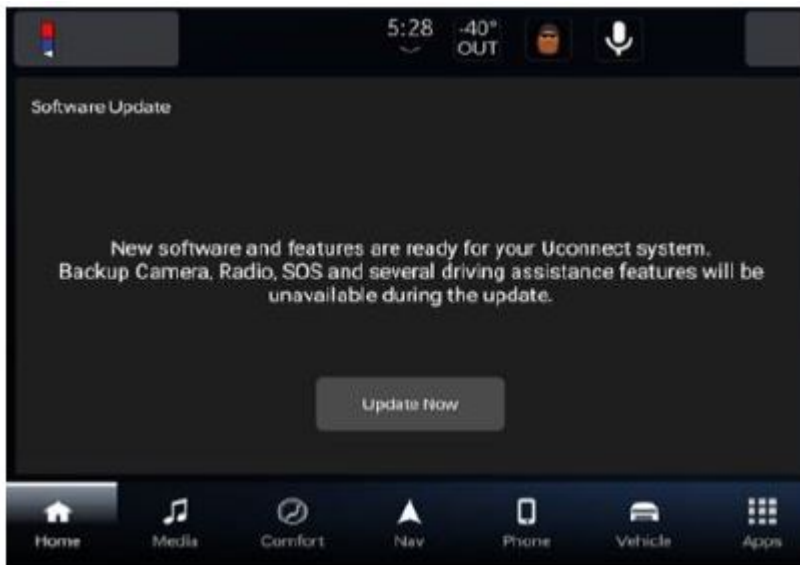
Fig. 2

Software Acceptance Screen

1. The vehicle needs to be in 'Park'. The ignition needs to be in the off position.
2. If the customer selects “Update Now” (Fig. 2) they can shut off the vehicle and leave. The update will be completed automatically.
