Technical Service Bulletin (TSB)
Service Air Suspension Message On

REFERENCE:	TSB: 02-006-23 GROUP 02 - Front Suspension	Date:	August 19, 2023	REVISION:	-
VEHICLES AFFECTED:	2023 (WL) Jeep Grand Cherokee This bulletin applies to vehicles built on or before May 16, 2023 (MDH 0516XX) equipped with Quadra-Lift Air Suspension (Sales Code SER).	MARKET APPLICABILITY:			
		<input checked="" type="checkbox"/> NA <input type="checkbox"/> CH <input type="checkbox"/> EE <input type="checkbox"/> IAP <input type="checkbox"/> SA <input checked="" type="checkbox"/> MEA			
CUSTOMER SYMPTOM:	<p>Customers may experience a Malfunction Indicator Lamp (MIL) illumination. Upon further investigation the technician may find that one or more of the following Diagnostic Trouble Codes (DTCs) have been set:</p> <ul style="list-style-type: none"> • C15A1-00 - Unable To Obtain Desired Ride Height. • C1509-00 - Low Airmass. <p>Customer may also comment on one or more of the following:</p> <ul style="list-style-type: none"> • Service Air Suspension message on in the Electronic Vehicle Information Center (EVIC). • One corner of the vehicle is sagging. • Vehicle may not be able to achieve desired ride height.

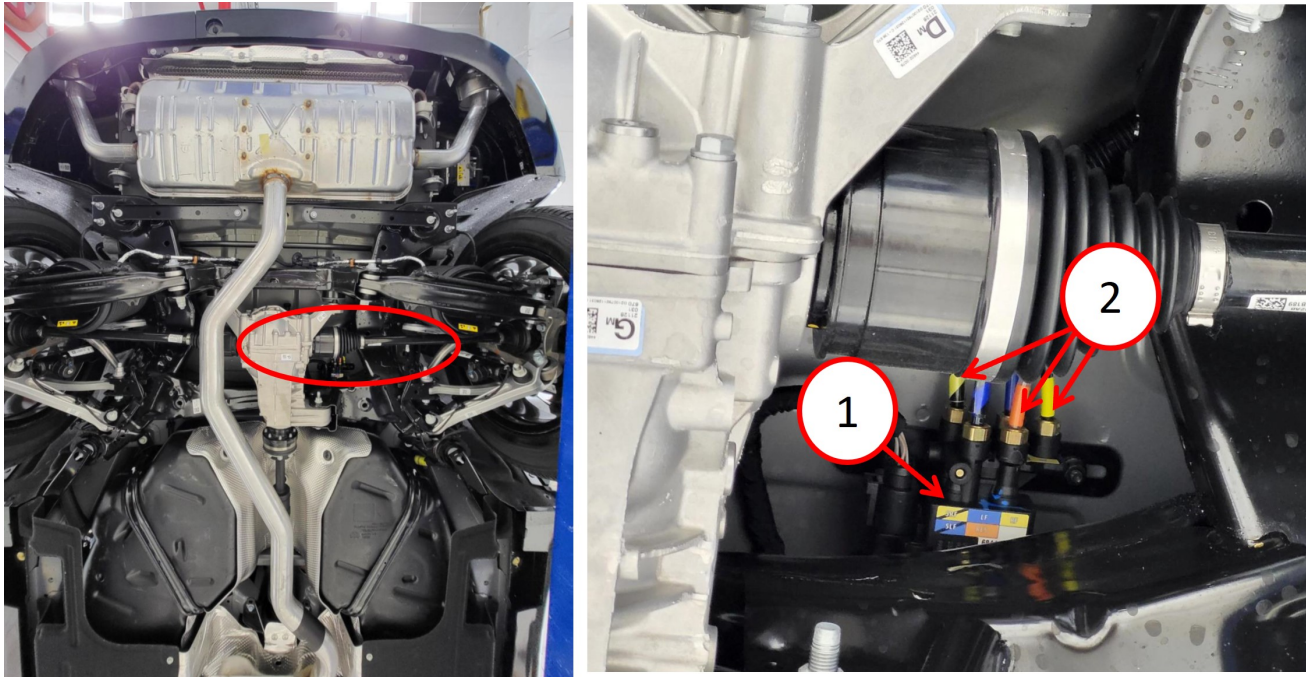
Fig. 1
Fast Down Leveling Valve And Air Lines

CAUSE:	Air line(s) may not be fully seated.

1. Hoist vehicle. Raise and support the vehicle. Refer to the detailed service procedures available in DealerCONNECT/Service Library under: Service Info>04 - Vehicle Quick Reference / Hoisting / Standard Procedure.
2. Visually confirm the air lines are fully bottomed out in the fast down leveling valve up to the colored tape (Fig. 1) .

3. Were any air lines not fully bottomed out in the fast down leveling valve and up to the colored tape (Fig. 1) ?
 - YES>>> Proceed to [Step 1](#) of the Repair Procedure.
 - NO>>>This bulletin does not apply. Normal diagnosis should be performed. Use inspect LOP (02-66-01-9A) to close the active RSU.

1. Push all five air lines into the fast down leveling valve and up to the colored tape (Fig. 1) .
2. Confirm all five air lines are seated with a push-pull-push test.
3. Clear any DTCs that may have been set.
