# Technical Service Bulletin (TSB)

**Passenger Heated Seat Cushion Inoperative**

REFERENCE:	TSB: 23-091-23 GROUP 23 - Body	Date:	August 19, 2023	<b>REVISION:</b>	-
VEHICLES AFFECTED:			MARKET APPLICABILITY:		
ATTECTED.			⊠NA	□CH	
			EE	□IAP	
				□SA	□MEA
CUSTOMER SYMPTOM:	Passenger heated seat does not work.				
CAUSE:	Heated seat mat pinched/cut by seat ring clamp.

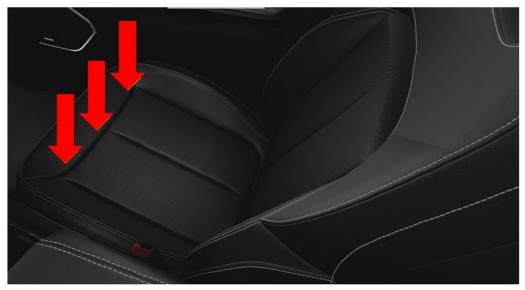
1. Press down firmly five times, in three locations (Fig. 1) at front seat seam on the passenger seat cushion.

Fig. 1 Three Seat Cushion Locations To Press Down
