<b>REFERENCE:</b>	<b>TSB:</b> 10-001-23 <b>GROUP</b> 10 - Restraints	<b>Date:</b>	August 25, 2023	<b>REVISION:</b>	
<b>VEHICLES AFFECTED:</b>	2015 - 2022 (B1) Jeep Renegade 2015 - 2018 (BU) Jeep Renegade 2019 - 2022 (BV) Jeep Renegade 2019 - 2022 (FD) Fiat 500X 2015 - 2018 (FB) Fiat 500X This bulletin applies to vehicles built on before December 31, 2022 (MDH 1231XX)	<b>MARKET APPLICABILITY:</b>			
		<input type="checkbox"/> NA		<input checked="" type="checkbox"/> MEA	
		<input checked="" type="checkbox"/> SA		<input checked="" type="checkbox"/> IAP	
		<input checked="" type="checkbox"/> EE		<input type="checkbox"/> CH	
<b>CUSTOMER SYMPTOM:</b>	Customers may experience a Malfunction Indicator Lamp (MIL) illumination. Upon further investigation the technician may find one or more of the following Diagnostic Trouble Codes (DTCs) has been set: <ul style="list-style-type: none"> <li>• B0050-1D - Driver Front Buckle Switch - Out of Range (Active or Stored).</li> <li>• B0050-13 - Driver Front Buckle Switch - Circuit open (Active or Stored).</li> </ul>

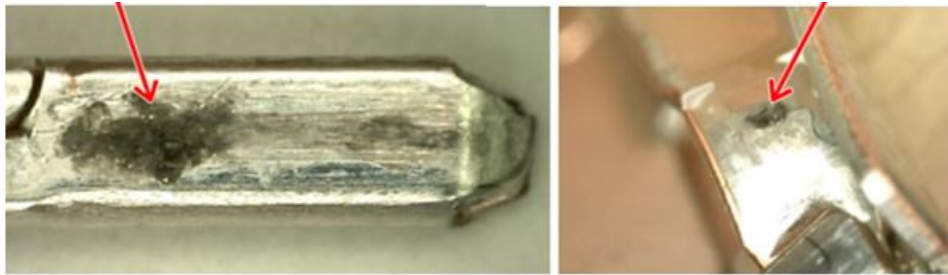
<b>CAUSE:</b>	Micro vibrations between buckle and seat wiring connectors causing male and female terminal corrosion (Fig. 1) .

**Fig. 1**  
**Terminal Corrosion**

This bulletin involves replacing the inline seat connector.

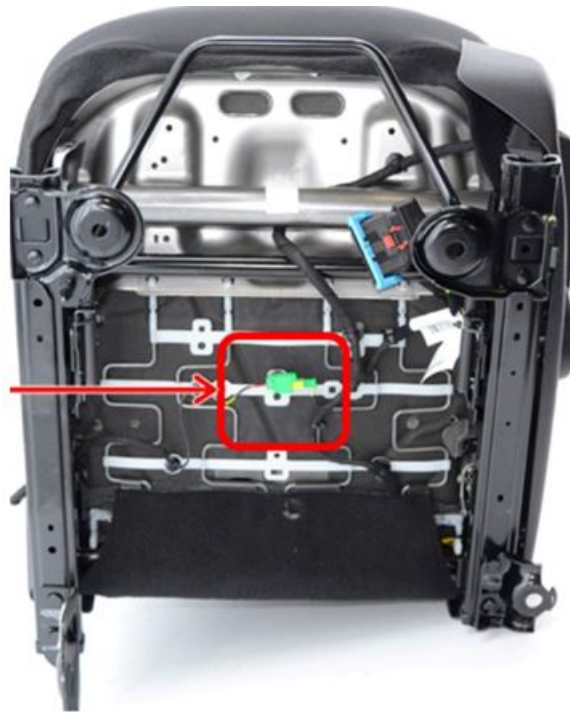
1. Remove the front driver's seat and put it on a clean work area. Refer to the detailed service procedures available in DealerConnect>Service Library under: Service Info> 23 - Body / Seats, First Row / Seat, Front / Removal.
2. On the seat bottom, locate the seat belt buckle in line connector (Fig. 2) .

**Fig. 2**  
**Seat Belt Buckle In Line Connector Location**

3. Remove the old seat belt buckle connector.

4. Splice in the new in line connector. Refer to the detailed service procedures available in DealerConnect>Service Library under: Service Info> 10 - Restraints / Standard Procedure Supplemental Restraint System Wiring Repairs.
5. After replacing the connector, apply WURTH Silicone Spray 0893223 grease or equivalent product. A small amount is needed to be applied on the pins of the female connector (seat belt side) .
6. Install the front driver's seat. Refer to the detailed service procedures available in DealerConnect>Service Library under: Service Info> 23 - Body / Seats, First Row / Seat, Front / Installation.
7. Using wiTECH clear all DTC that may have been set performing this repair procedure.
