**Technical Service Bulletin (TSB)**  
**Radio Firmware Over The Air (FOTA) Update to T25.48 Software Version**

<b>REFERENCE:</b>	<b>TSB:</b> 08-203-23 <b>GROUP</b> 08 - Electrical	<b>Date:</b>	August 25, 2023	<b>REVISION:</b>	—
<b>VEHICLES AFFECTED:</b>	<p>2022 (DT) RAM 1500 Pickup                  2022 (DJ) RAM 2500 Pickup                  2022 (D2) RAM 3500 Pickup                  2022 (DD) RAM 3500 Cab Chassis                  2022 (DF) RAM 3500 10K Lb. Cab Chassis                  2022 (DP) RAM 4500/5500 Cab Chassis</p> <p><b>This bulletin applies to vehicles equipped with either:</b></p> <ul style="list-style-type: none"> <li>• Uconnect 5 NAV W 8.4" Display (Sales Codes UBL and UEL) without Surround View Camera System (-XAK)</li> <li>• Uconnect 5 NAV W 12.0" Display (Sales Codes UBQ and UEQ) without Surround View Camera System (-XAK).</li> </ul>			<b>MARKET APPLICABILITY:</b>	
				<input checked="" type="checkbox"/> NA	<input type="checkbox"/> MEA
				<input type="checkbox"/> SA	<input type="checkbox"/> IAP

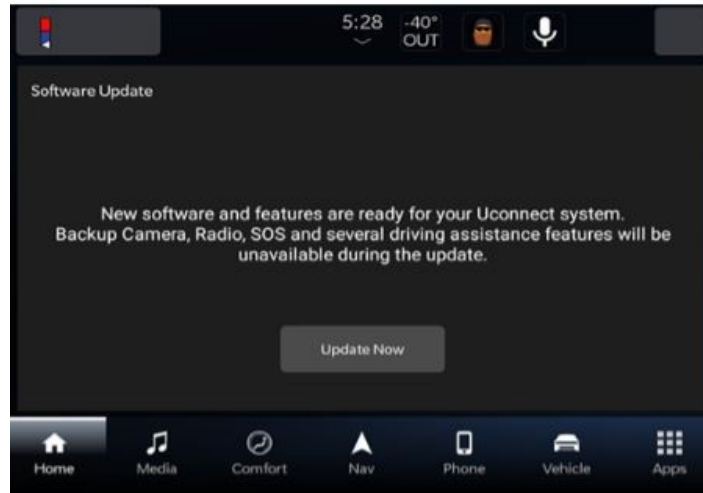
**Fig. 1**  
**Software Acceptance Screen**

Customers will see a notification on their radio screen when new software is available for their radio (Fig. 1). The owner will have the option to update the radio or schedule the update for later. There is not an option to decline the update indefinitely, the update must be performed.

1. The vehicle needs to be in 'Park'. The ignition needs to be in the off position.
2. If the customer selects "Update Now" they can shut off the vehicle and leave. The update will be completed automatically.

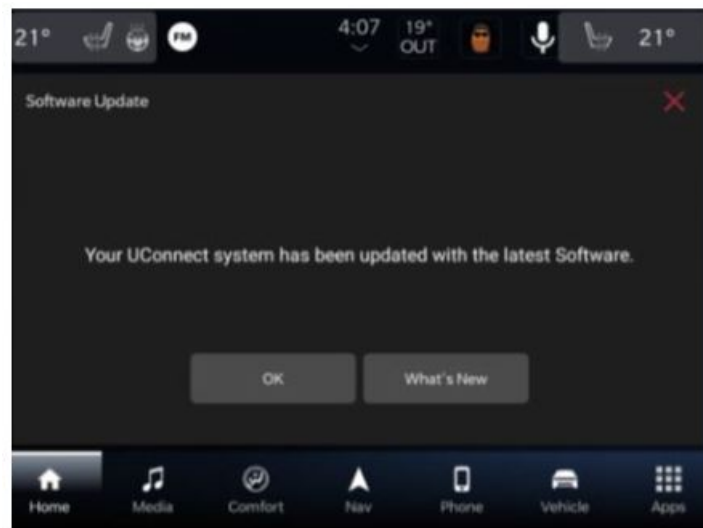
**Fig. 2**  
**Software Update Confirmation Screen**

3. Upon completion of update, the radio will display a confirmation message (Fig. 2).
