REFERENCE:	TSB: 09-014-23 GROUP 09 - Engine	Date:	August 29, 2023	REVISION:	-
VEHICLES AFFECTED:	<p>2023 (B1) Jeep Renegade 2023 (M1) Jeep Compass This bulletin applies to:</p> <ul style="list-style-type: none"> • B1 vehicles built on or after May 15, 2023 (MDH 0515XX) on or before July 17, 2023 (MDH 0717XX) and • M1 vehicles built on or after May 15, 2023 (MDH 0515XX) on or before July 13, 2023 (MDH 0713XX) <p>Equipped with a 1.3 I4 Turbo MAIR DI Engine W/ESS (Sales Code EYJ).</p>	MARKET APPLICABILITY:			
		<input type="checkbox"/> NA <input type="checkbox"/> MEA		<input type="checkbox"/> IAP	
		<input checked="" type="checkbox"/> SA <input type="checkbox"/> EE		<input type="checkbox"/> CH	
CUSTOMER SYMPTOM:	<p>Customers may experience a Malfunction Indicator Lamp (MIL) illumination. Upon further investigation the technician may find that the following Diagnostic Trouble Code (DTC) has been set:</p> <ul style="list-style-type: none"> • P1212 - Engine Oil Temperature High - RPM Limited. <p>Customers may also experience the following:</p> <ul style="list-style-type: none"> • Engine overheating.

CAUSE:	Incorrect cylinder head-to-block fasteners.

This bulletin involves inspecting an

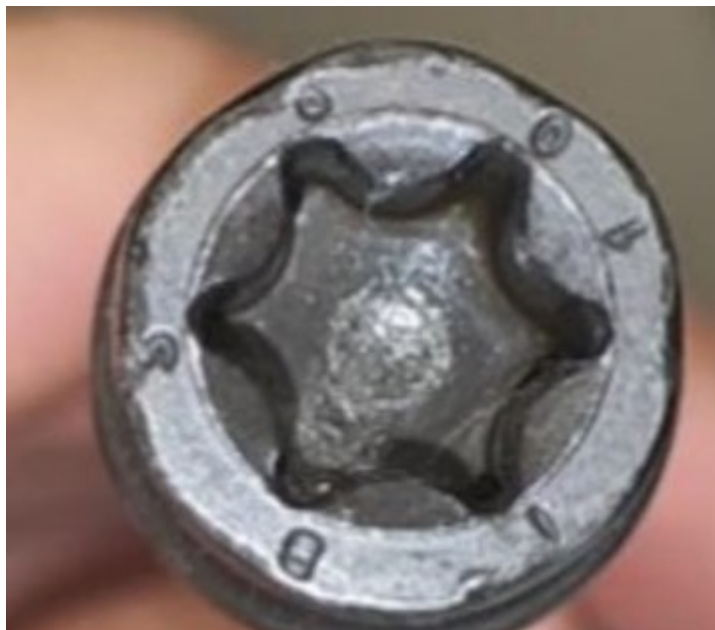
Fig. 1
Correct Head fastener

- YES>>> Proceed to [Step 1](#) of the Repair Procedure.
 - NO>>> Proceed to [Step 4](#).
4. Remove the MultiAir module. Refer to the detailed service procedures available in DealerCONNECT/ Service Library under: 09 - Engine, 1.3L I4 16V MultiAir Turbo / Cylinder Head / Assembly, Variable Valve Actuation / Removal and Installation.
 5. Verify if the head fastening screws have the correct vendor markings: ([Fig. 1](#)) .

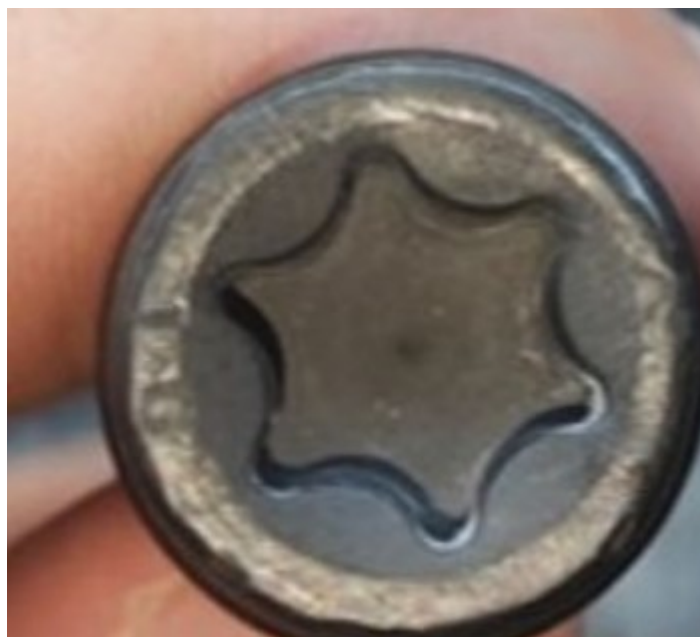
Fig. 2
Incorrect Head Fastener

NOTE: Incorrect vendor markings: ([Fig. 2](#))

6. If there are no markings on the screws ([Fig. 2](#)) , and it is an **unsold** vehicle, proceed to [Step 10](#) of the Inspection Procedure. But if it is a **sold** vehicle, proceed to [Step 1](#) of the Repair Procedure.
7. If there are markings on the screws, proceed to [Step 8](#).

11. Remove the camshaft. Refer to the detailed service procedures available in DealerCONNECT/Service Library under: 09 - Engine, 1.3L I4 16V MultiAir Turbo / Cylinder Head / Camshaft, Engine / Removal and Installation.
 12. Replace the incorrect screw(s) with the correct screws.
- NOTE: Be sure only to remove and replace ONE screw at a time.**
13. Loosen the screws in three turns.
 14. Retighten the head screws by following this three-step method (torque plus angle) in the sequence shown (Fig. 3) .
