<b>REFERENCE:</b>	<b>TSB:</b> 23-093-23 <b>GROUP</b> 23 - Body	<b>Date:</b>	August 29, 2023	<b>REVISION:</b>	-
<b>VEHICLES AFFECTED:</b>	<b>2023 (WS) Grand Wagoneer/Wagoneer</b> This bulletin applies to vehicles built on or after January 23, 2023 (MDH 0123XX) and on or before April 06, 2023 (MDH 0406XX) equipped with Middle East Equipment Group (Sales Code ABD).	<b>MARKET APPLICABILITY:</b>			
<b>CUSTOMER SYMPTOM:</b>	The front fascia may be damaged during off road driving/driving over obstacles (air dam sits too low allowing for sand intrusion) (Fig. 1) .				
<b>CAUSE:</b>	Incorrect air dam installed.

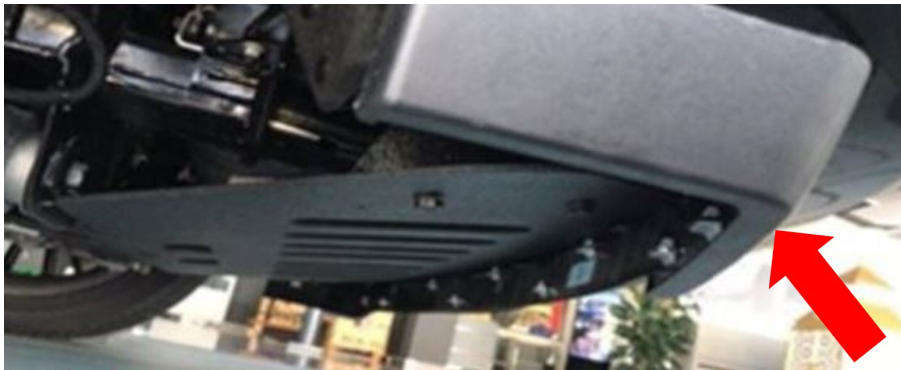
**Fig. 1**  
**Incorrect Air Dam Installed**

This bulletin involves replacing the front air dam.

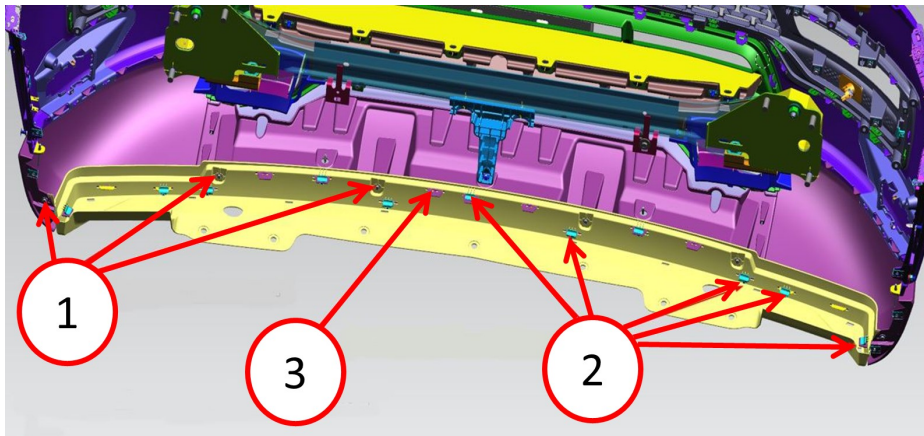
**Fig. 2**  
**Air Dam Fasteners**

- 1 - Six Hex Head Bolts  
2 - Shoe Clips  
3 - Snap Tabs

1. Raise and support the vehicle. Refer to the detailed service procedures available in DealerCONNECT/ Service Library under: Service Info>04 - Vehicle Quick Reference / Hoisting / Standard Procedure.
2. Replace the air dam by removing the six hex head bolts from the air dam (Fig. 2) .

3. Using a trim stick, unfasten the 11 shoe clips (Fig. 2) .
4. Using a trim stick, unseat the remaining snap tabs (Fig. 2) and pull the air dam off.
5. Install the new air dam by seating the snap tabs (Fig. 2) .
6. Fasten the 11 shoe clips (Fig. 2) .
7. Install the six hex head bolts on the air dam (Fig. 2) . Tighten the bolts to 3.2 N·m (28 in. lbs.).
8. Lower the vehicle.
