**Technical Service Bulletin (TSB)**  
**Interior Trim Panel Has Large Gap Right Hand Drive (RHD)**

<b>REFERENCE:</b>	<b>TSB:</b> 08-207-23 <b>GROUP</b> 08 - Electrical	<b>Date:</b>	August 30, 2023	<b>REVISION:</b>	—
<b>VEHICLES AFFECTED:</b>	2023 (JL) Jeep Wrangler This bulletin applies to vehicles built on or after October 24, 2022 (MDH 1024XX) equipped with Right Hand Drive (Sales Code 5I9).			<b>MARKET APPLICABILITY:</b>	
				<input type="checkbox"/> NA	<input type="checkbox"/> CH
				<input checked="" type="checkbox"/> EE	<input checked="" type="checkbox"/> IAP
				<input type="checkbox"/> SA	<input checked="" type="checkbox"/> MEA
<b>CUSTOMER SYMPTOM:</b>	<b>Customers may notice the following:</b> <ul style="list-style-type: none"> <li>• Passenger side lower trim panel not seated flush (large gap).</li> </ul>				
<b>CAUSE:</b>	Door wire harness not in proper location.

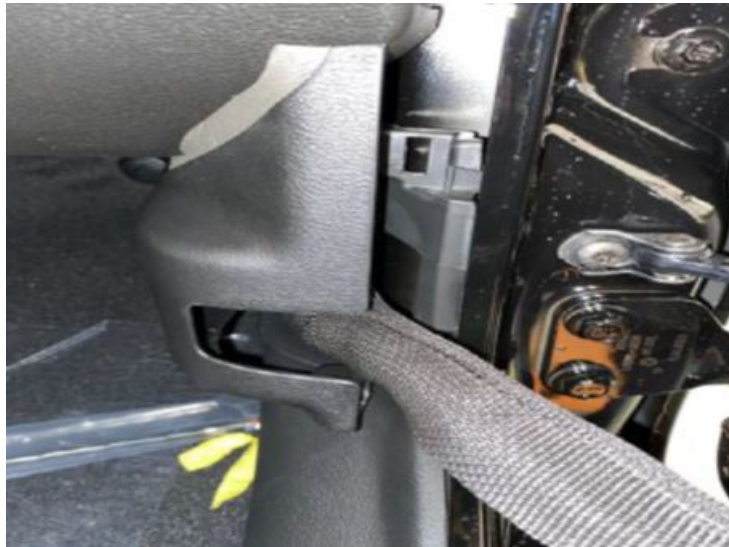
1. Visually inspect the right front door harness wire cover for large gaps and not properly seated ([Fig. 1](#)) .

**Fig. 1**  
**Trim Panel Not Properly Seated**

2. Is there a large gap between the trim plane and body ([Fig. 1](#)) ?
  - YES>>> Proceed to [Step 3](#).
  - NO>>> This bulletin has been completed. Use Inspection LOP (08-92-KG-90) to close the active RSU.
3. Use a trim stick to help remove the wire cover trim panel ([Fig. 2](#)) .

This bulletin involves inspecting and if needed move wire harness retainer to lower mounting location.

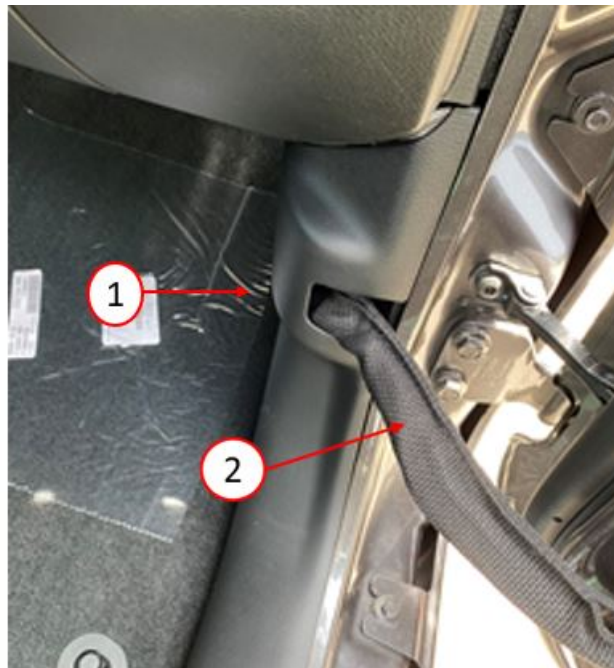
**Fig. 2**  
**Trim Panel Location**

- 1 - Wire Harness Trim Panel  
2 - Door Wire Harness

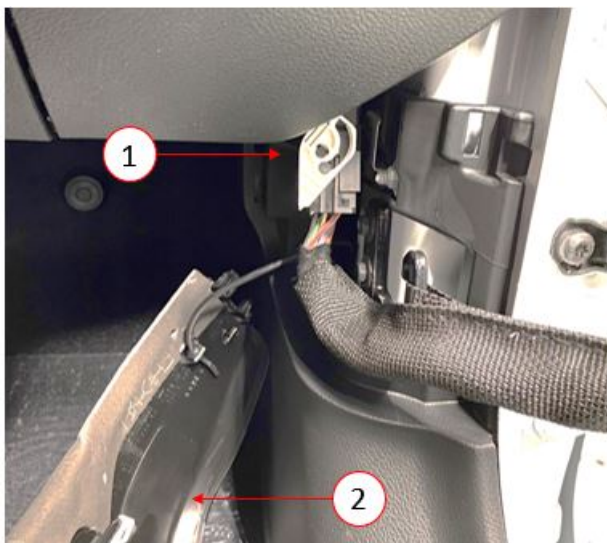
**Fig. 3**  
**Wire harness Without Trim Panel**

- 1 - Door Wire Harness Connector
- 2 - Wire Harness Trim Panel

4. Locate the wire harness just above the door connector (Fig. 3) .

**NOTE: The wire harness retaining clip needs to be removed from the upper mounting hole and installed in the lower mounding hole. This retaining clip is hard to see and this Repair Procedure has to been done blind, only by feel.**

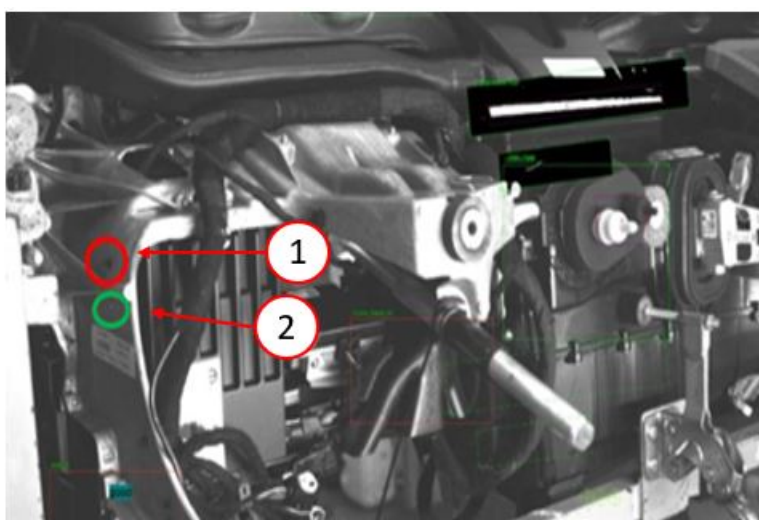
**Fig. 4**  
**Harness Retaining Clip Mounting Location**

- 1 - Incorrect Mounting Hole Location
- 2 - Correct Mounting Hole Location

5. Reach up above the door connector and follow the wire harness with your hand. Locate where the wire harness retaining clip is fastened to the body.
6. Using a trim stick, push it under the retaining clip. Pull out on the removal tool to loosen the retaining clip.
7. Move the retaining clip to the lower mounting hole. The picture below is of a instrument panel sitting on a workbench, for demonstration purpose only (Fig. 4) .

8. Once the lower mounting hole is located, push the retaining clip into the lower mounting hole location.
9. Reposition the door harness so it will not interfere with the trim panel.
10. Install the lower trim panel.
