Technical Service Bulletin (TSB)
Interior Trim Panel Has Large Gap Right Hand Drive (RHD)

REFERENCE:	TSB: 08-207-23 REV. A GROUP 08 - Electrical	Date:	August 31, 2023	REVISION:	08-207-23
VEHICLES AFFECTED:	2023 (JL) Jeep Wrangler This bulletin applies to vehicles built on or after **October 21, 2022 (MDH 1021XX)** equipped with Right Hand Drive (Sales Code 519).	MARKET APPLICABILITY:			
		<input type="checkbox"/> NA <input type="checkbox"/> CH <input checked="" type="checkbox"/> EE <input checked="" type="checkbox"/> IAP <input type="checkbox"/> SA <input checked="" type="checkbox"/> MEA			
CUSTOMER SYMPTOM:	Customers may notice the following: <ul style="list-style-type: none"> Passenger side lower trim panel not seated flush (large gap). 				
CAUSE:	Door wire harness not in proper location.

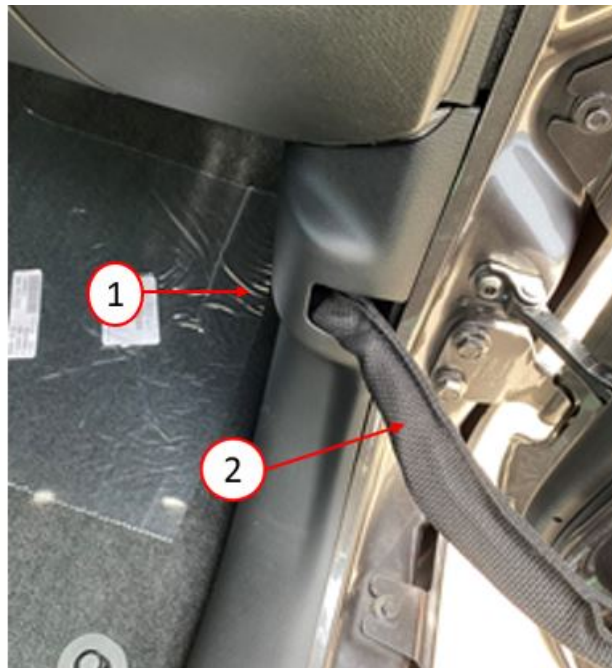
Fig. 2
Trim Panel Location

- 1 - Wire Harness Trim Panel
2 - Door Wire Harness
-

2. Is there a large gap between the trim plane and body ([Fig. 1](#)) ?
 - YES>>> Proceed to [Step 3](#).
 - NO>>> This bulletin has been completed. Use Inspection LOP (08-92-KG-90) to close the active RSU.
3. Use a trim stick to help remove the wire cover trim panel ([Fig. 2](#)) .
