SS 3123 - FTL 2023 P4 New Cascadia Web Mounted 5th Wheel Ramps

Freightliner New Cascadia vehicles equipped with Holland air sliding 5th wheels (Family Data Code 578-A02) and frame rail web mounted ramps.

Build dates between 01/01/2019 and 07/01/2023

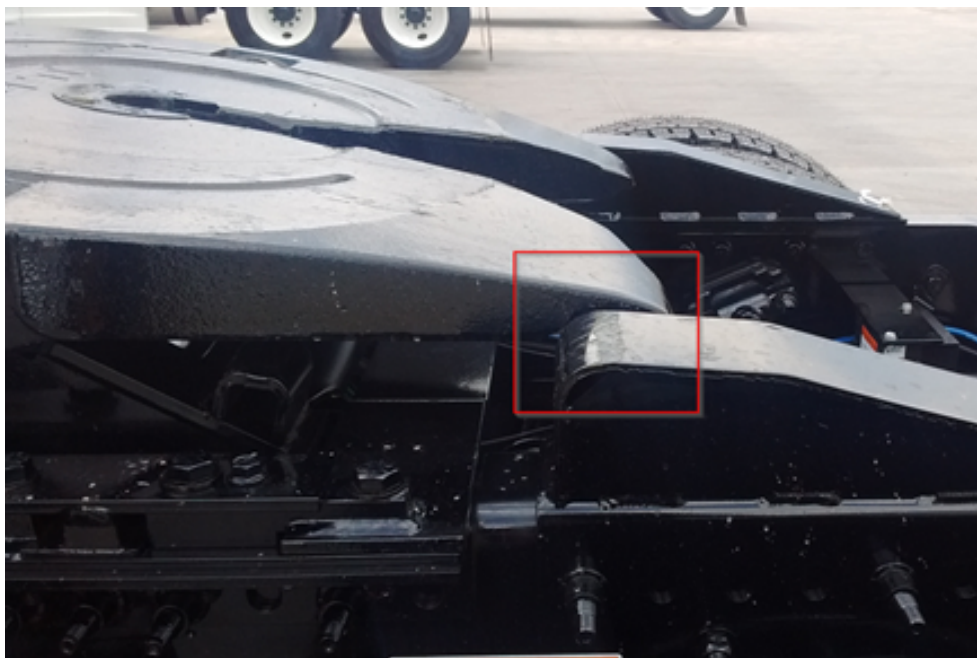
On certain tractor configuration vehicles, when the 5th wheel is slid aft, there is potential for the 5th wheel top plate to contact the 5th wheel ramps. This interference restrains the 5th wheel top plate from reaching the designed lowest position when the tractor is in the unloaded configuration. (See picture below).

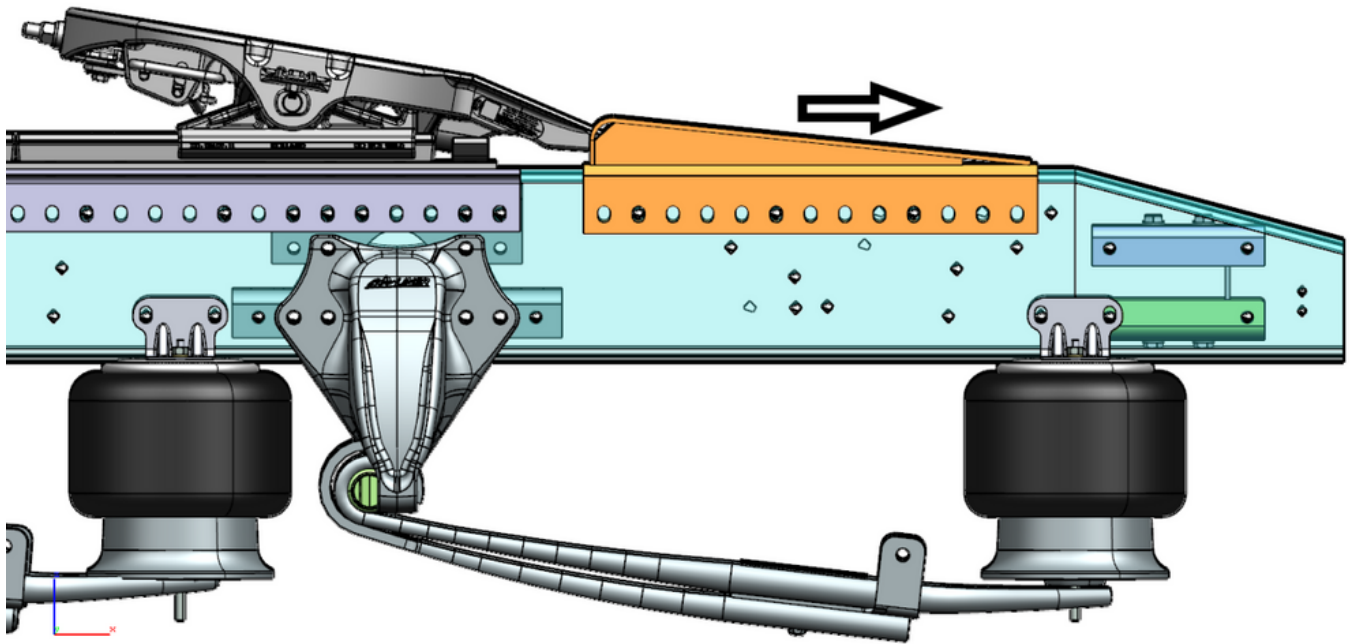
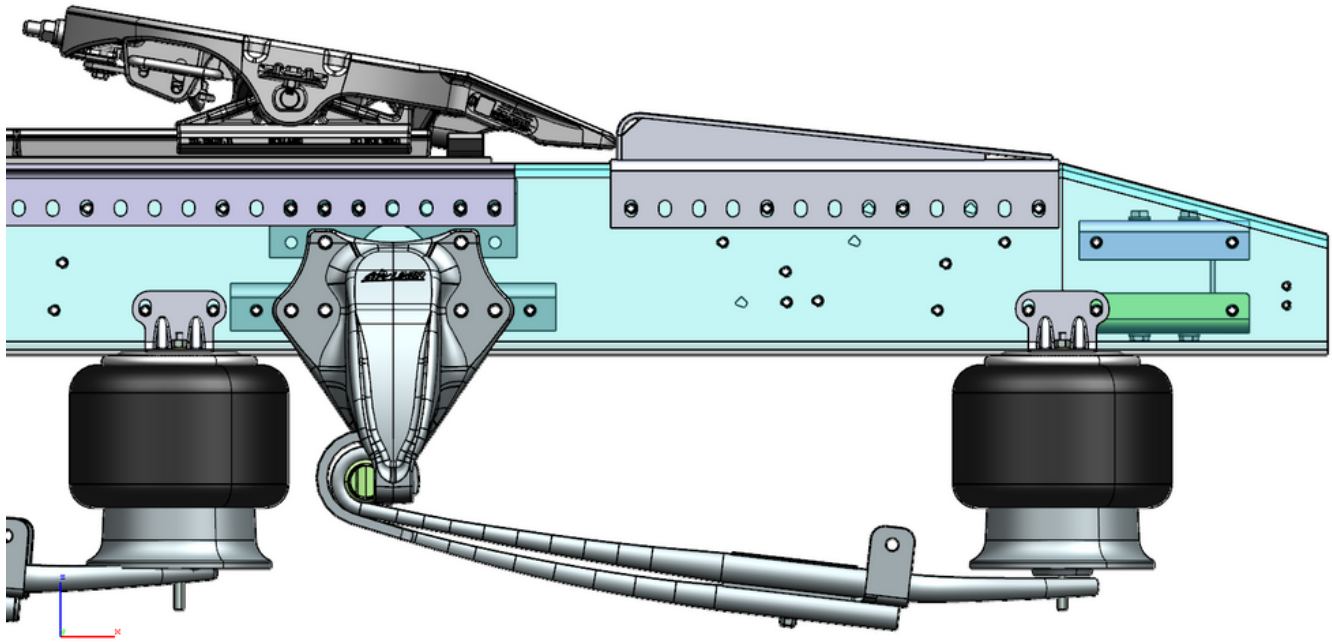
To avoid the symptoms reported above, web mounted 5th wheel ramps were modified at the truck manufacturing plant. A potential interference issue is possible when a dealer/customer orders new unmodified replacement 5th wheel ramps.

- Move the replacement 5th wheel ramps one frame rail grid hole aft to provide the required clearance. (See pictures below)
- If moving the replacement 5th wheel ramps one frame rail grid hole aft is not possible, modify the replacement ramp width to provide required clearance to the 5th wheel top plate. Use the width of the original factory installed ramps as a guide for the modification required.
