## SS 754 - WST 2023 49X and 47X Web Mounted 5th Wheel Ramps

Western Star 49X and 47X vehicles equipped with Holland air sliding 5th wheels (Family Data Code 578-A02) and frame rail web mounted ramps.

Build dates between 01/01/2019 and 07/01/2023

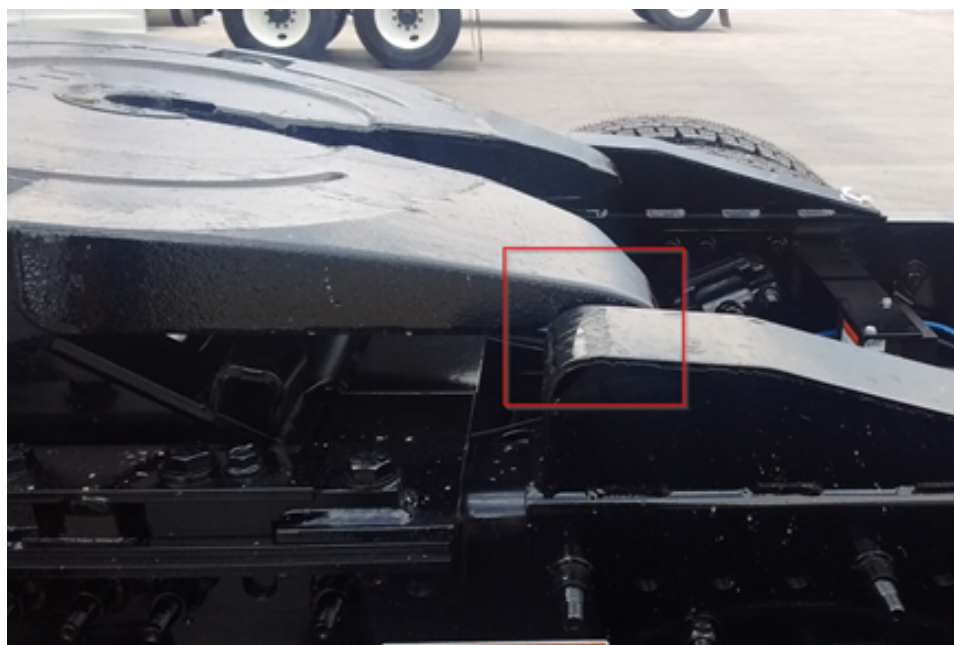
On certain tractor configuration vehicles, when the 5th wheel is slid aft, there is potential for the 5th wheel top plate to contact the 5th wheel ramps. This interference restrains the 5th wheel top plate from reaching the designed lowest position when the tractor is in the unloaded configuration. ( See picture below).

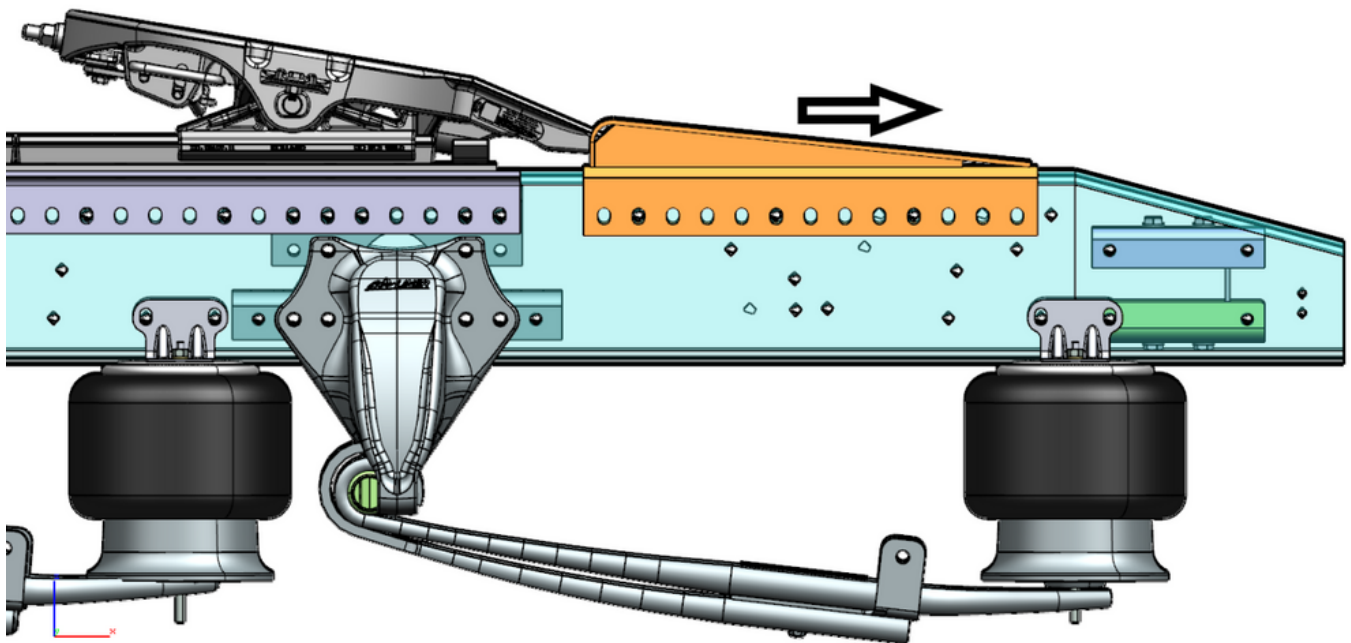
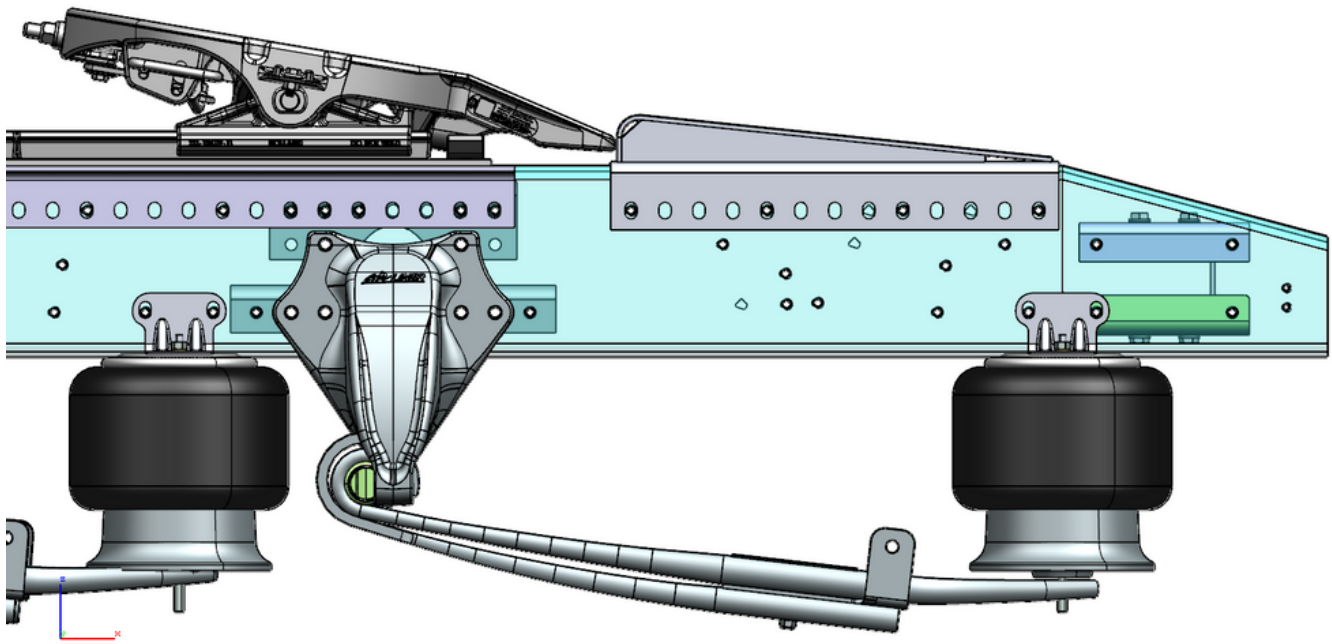
To avoid the symptoms reported above, web mounted 5th wheel ramps were modified at the truck manufacturing plant. A potential interference issue is possible when a dealer/customer orders new unmodified replacement 5th wheel ramps.

- Move the replacement 5th wheel ramps one frame rail grid hole aft to provide the required clearance. (See pictures below)
- If moving the replacement 5th wheel ramps one frame rail grid hole aft is not possible, modify the replacement ramp width to provide required clearance to the 5th wheel top plate. Use the width of the original factory installed ramps as a guide for the modification required.
