## Technical Service Bulletin

<b>GROUP</b>	<b>NUMBER</b>
<b>CAMPAIGN</b>	<b>23-01-069G-1</b>
<b>DATE</b>	<b>MODEL(S)</b>
<b>SEPTEMBER 2023</b>	<b>G80 Electrified (RG3 EV) GV60 Electric (JW1 EV) GV70 Electrified (JK1a EV)</b>

**SUBJECT:** DTC P1A9096 CHECK FOR ICCU & FUSE REPLACEMENT AND ICCU SOFTWARE UPDATE (SERVICE CAMPAIGN 907G)

*This bulletin supersedes 23-01-069G to add 2023-24MY GV70 Electrified (JK1a EV) vehicles.*

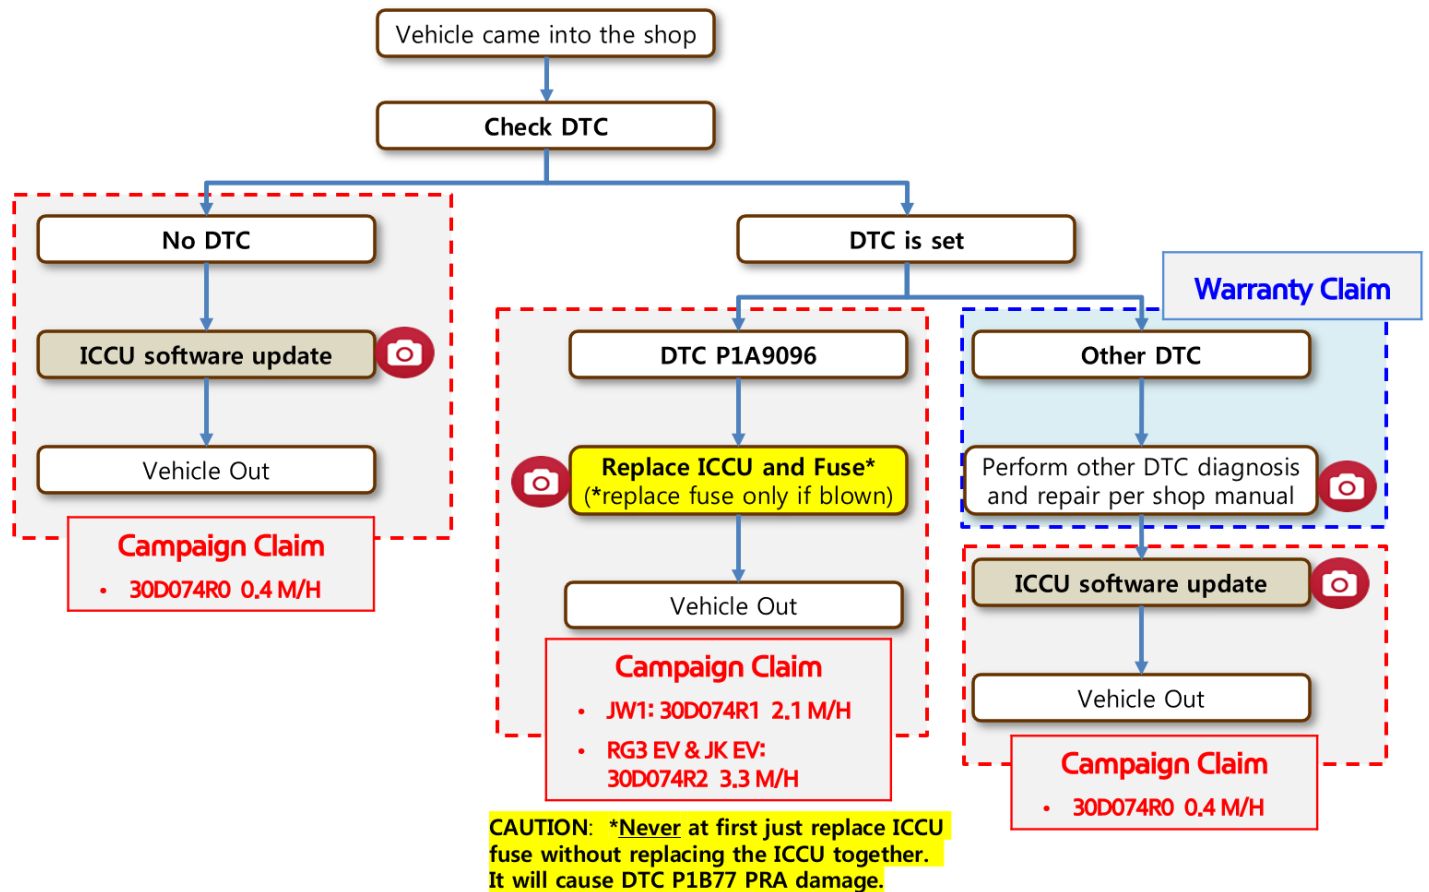
**Summary of Service Procedure Flow:**

The Service Procedure flow to be followed is outlined by the flowchart on Page-3. The ICCU system is to be checked by GDS for DTC P1A9096 and depending on the result, will involve either an ICCU software update, or ICCU and fuse replacement.

- A1. Perform All Fault Search by GDS.
- A2. **Check the ICCU system for DTC P1A9096. Is it either found as an active or history DTC?**
  - **No** – (DTC P1A9096 is not found stored):
    - Perform ICCU Software Update – see section B. **(Campaign Claim 0.4 M/H)**
    - NOTE: If any other DTC or symptom is found stored, diagnose and repair per shop manual before performing the ICCU Update. **(Warranty Claim)**
  - **Yes** – (DTC P1A9096 is found stored):
    - Replace ICCU:
      - GV60 (JW1 EV) – see section C
      - G80 Electrified (RG3 EV) – see section D
      - GV70 Electrified (JK1a EV) – see section E
    - Replace the ICCU Fuse.

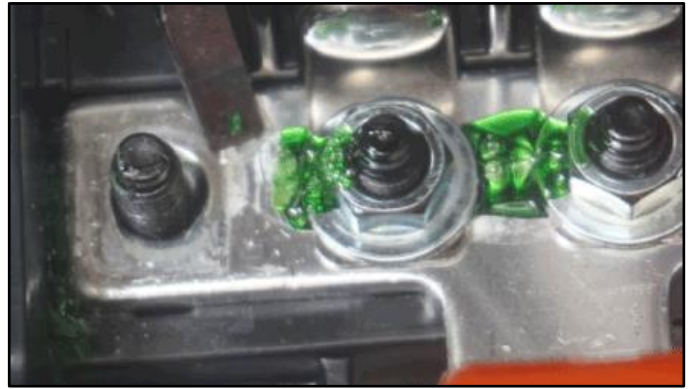
Any foreign substance in this area may cause poor contact between terminals.

- D4. After removing the bus bar, remove Loctite residue with a screwdriver or other tool.

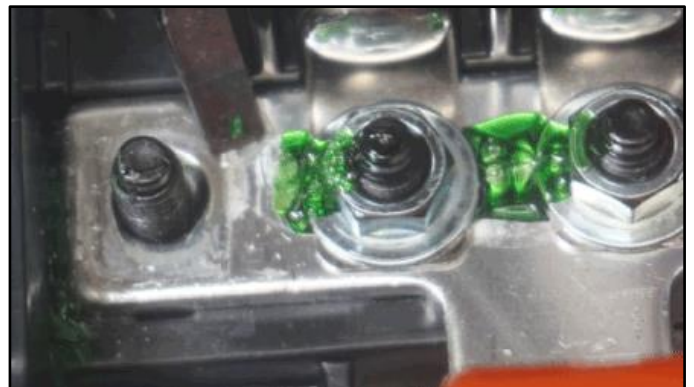
Any foreign substance in this area may cause poor contact between terminals.

E5. After removing the bus bar, remove Loctite residue with a screwdriver or other tool.
