SERVICE INFORMATION BULLETIN

NUMBER: 18-231-23
DATE: 09/11/23

SUBJECT: Service Manual Correction for EyeSight® Adjustment/Calibration Error Codes 1403-1407

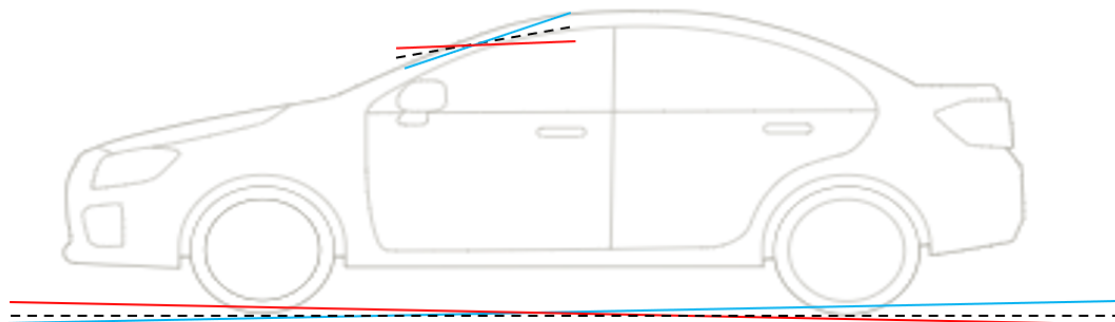
**13. The Tolerance Tilt (deg) MUST be within the specified range.
See Below**

Blue Line indicates Forward Tolerance Tilt
 Red Line indicates Backward Tolerance Tilt

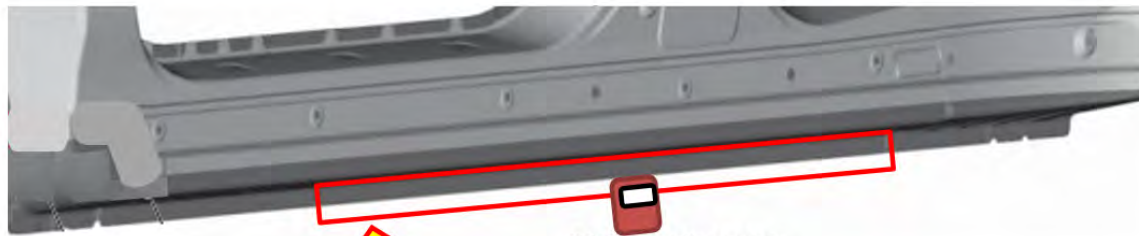
NOTE: Be sure to measure near the center of the side rocker panel and **NOT** on the jack positions.

Measurement location of side rocker panel for zero adjustment (lower end flange)

1. Perform a zero adjustment of the digital angle gauge at the left lower end flange side of the rocker panel. See the images below.
2. Measure the angle of the left center area of the rocker panel and record the reading.
3. Perform a zero adjustment of the digital angle gauge at the right lower end flange side of the rocker panel. See the images below.
4. Measure the angle of the right center area of the rocker panel and record the reading.

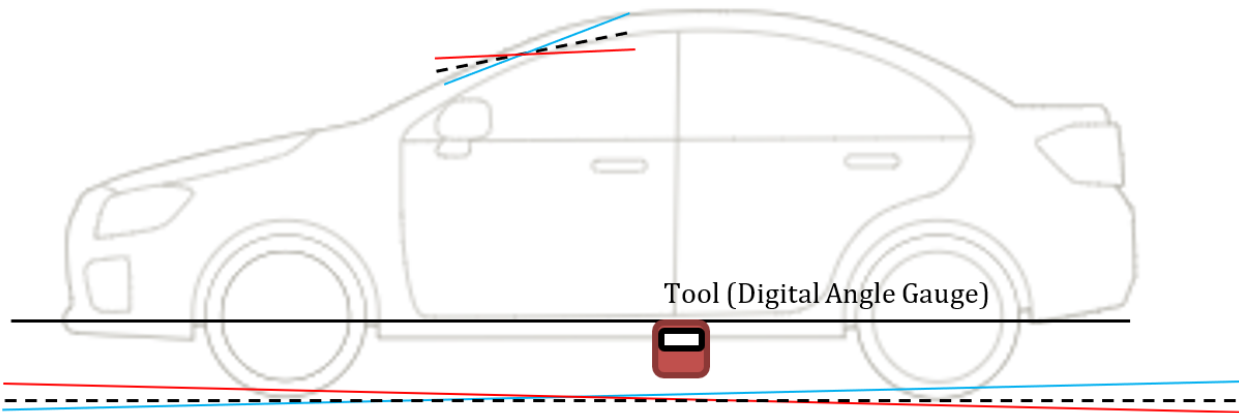
Tool (Digital Angle Gauge)

Blue Line indicates **Forward** Tolerance Tilt
Red Line indicates **Backward** Tolerance Tilt

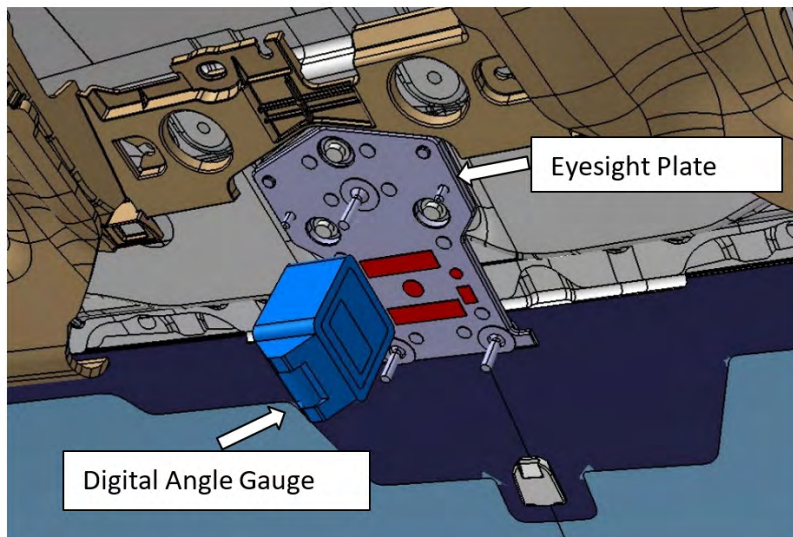
Eyesight Plate

Digital Angle Gauge

Measure the angle of the plate/stereo camera mount.
