Technical Service Bulletin

GROUP BODY	NUMBER 23-BD-015H
DATE SEPTEMBER 2023	MODEL(S) SANTA CRUZ (NXT)

SUBJECT: FUEL FILLER DOOR REPLACEMENT FOR PAINT IMPERFECTIONS

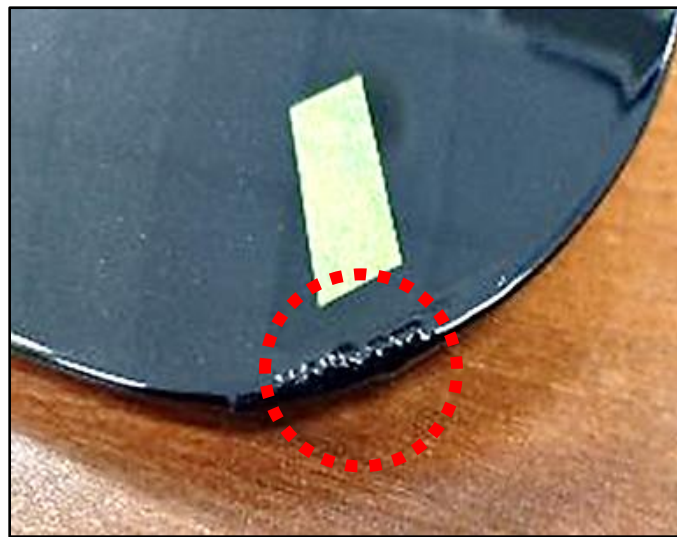
Figure 1: Paint Sag

3. Replace the fuel filler door (A) with a new part.

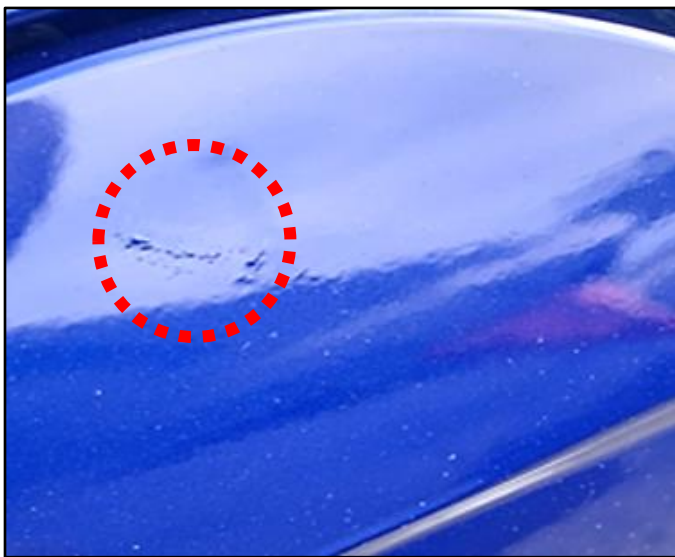
Figure 2: Paint Dirt

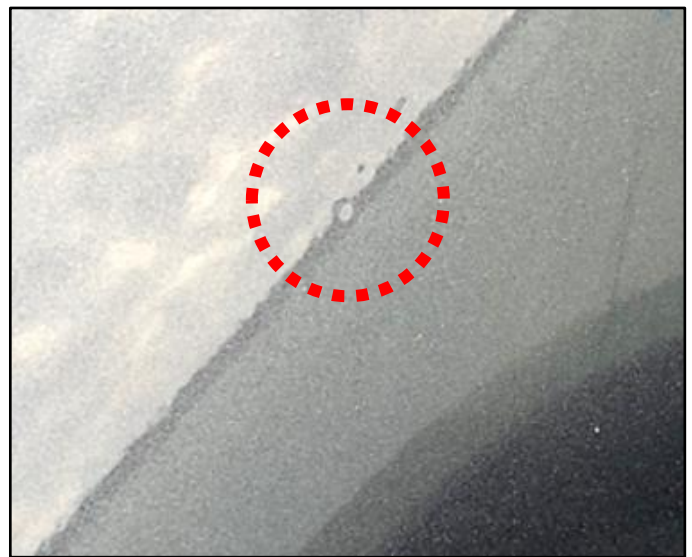
Figure 3: Paint Crater

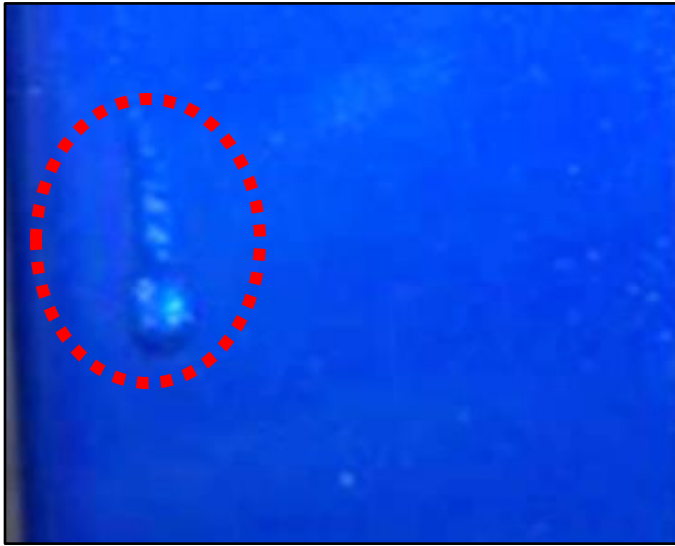
Figure 4: Paint Bubble

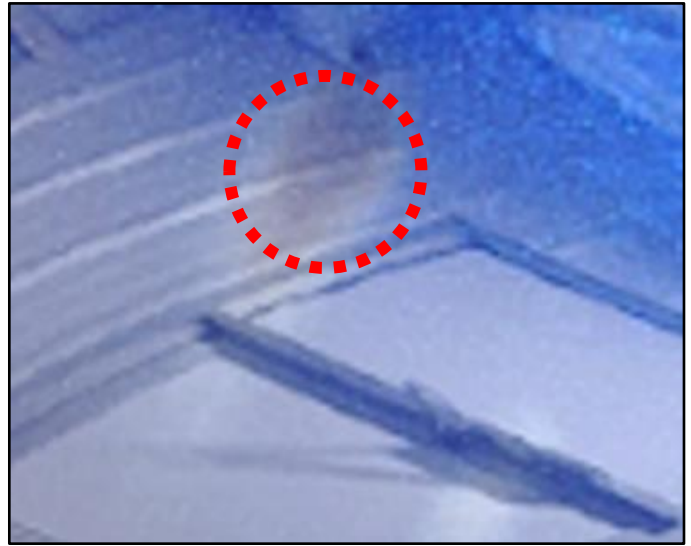
Figure 5: Paint Blemish
