PRODUCT CAMPAIGN BULLETIN

APPLICABILITY: 2019-20MY Ascent
 2020-21MY Legacy 2.4L (turbo models)
 2020-21MY Outback 2.4L (turbo models)

SUBJECT: CVT Chain Guide Breakage

NUMBER: WRK-21/22R

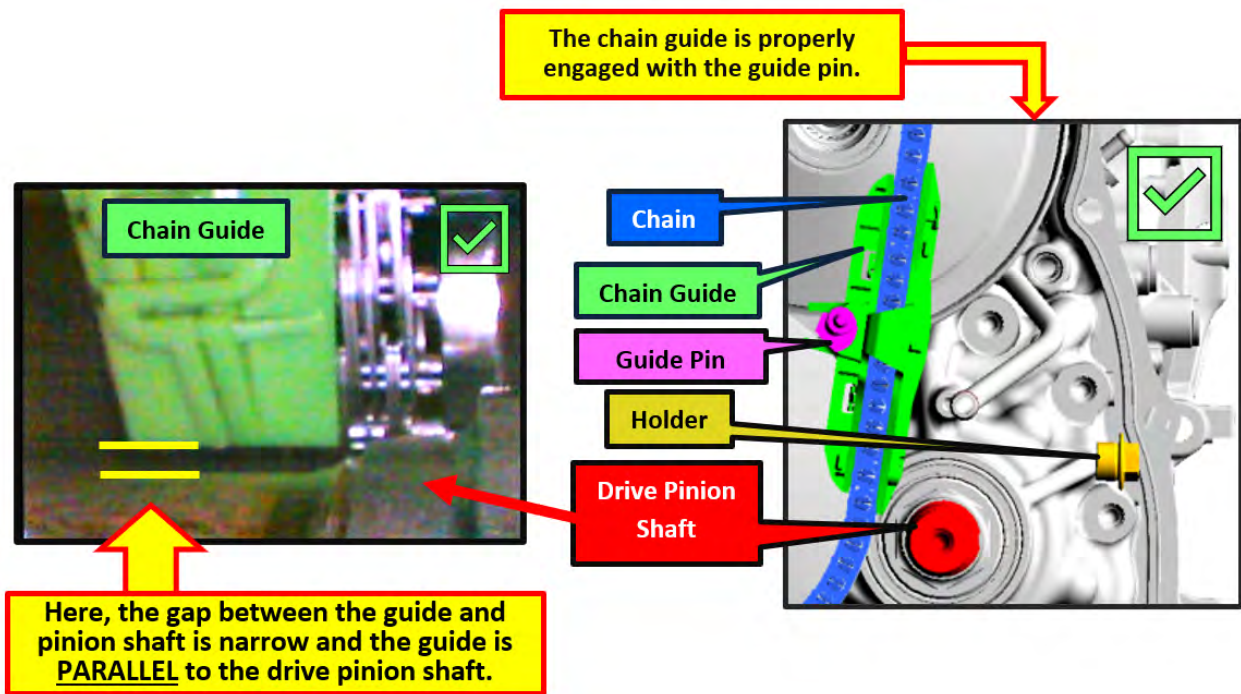
CORRECT GUIDE POSITIONING:

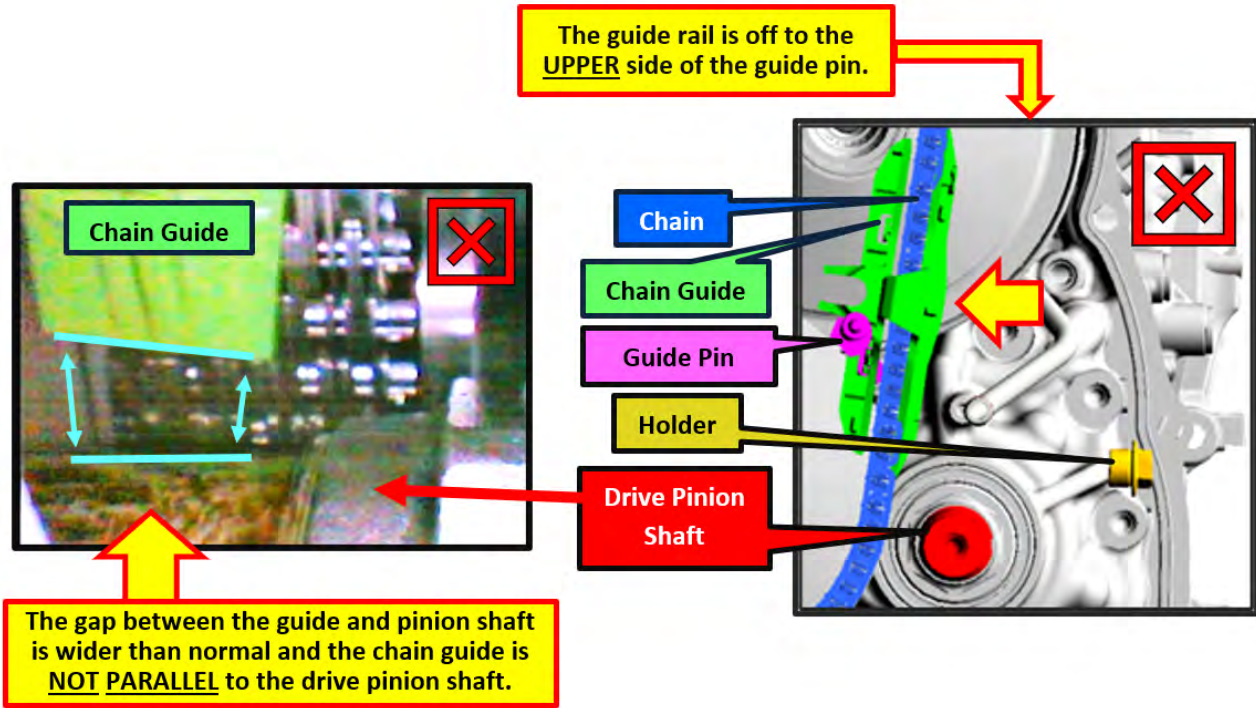
INCORRECT GUIDE POSITIONING 1:

STEP 4A: Replace the CVT assembly.

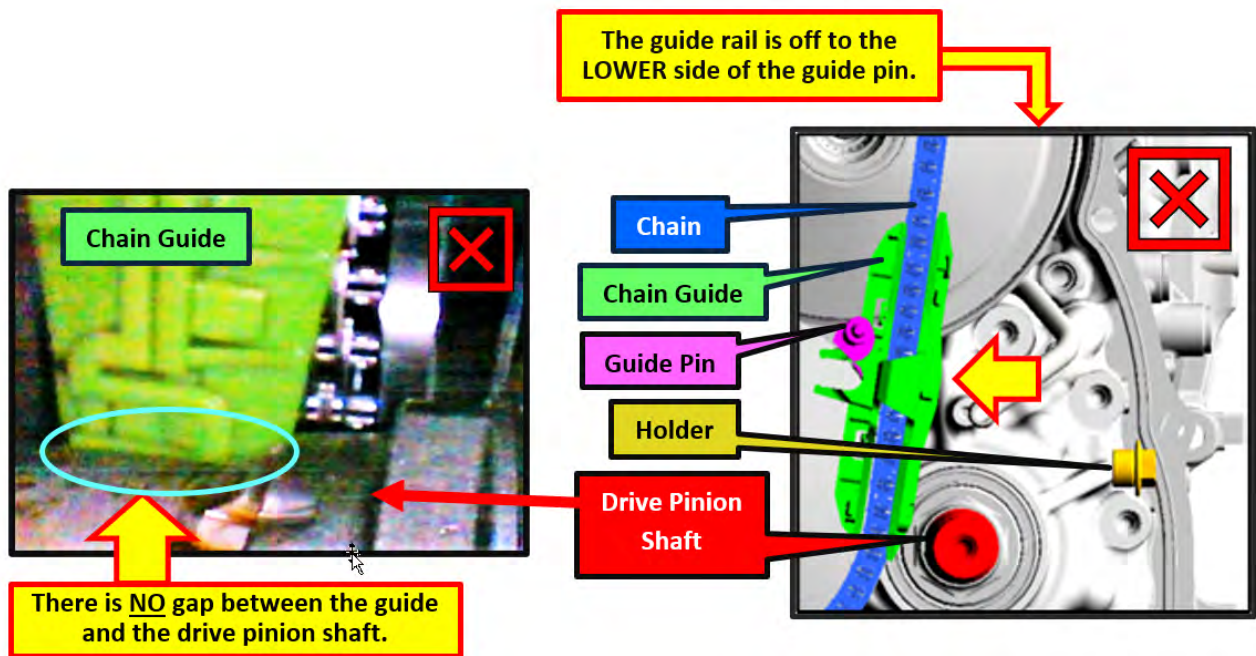
INCORRECT GUIDE POSITIONING 2:

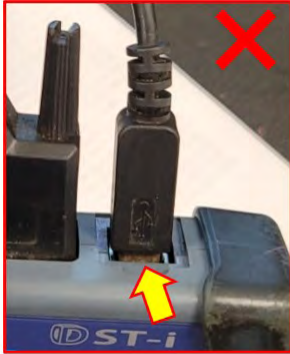
Corroded Connection

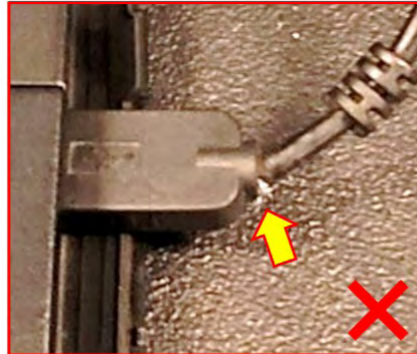
**Exposed Wiring &
Incorrect Cable**
