**SERVICE INFORMATION BULLETIN**

**APPLICABILITY:** 2020-23MY Legacy & Outback  
 2019-23MY Forester

**NUMBER:** 12-248-23R

**SUBJECT:** Rattle-Type Sound From B-Pillar Area

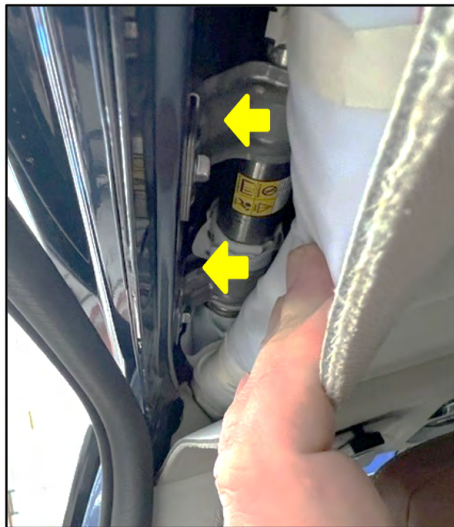
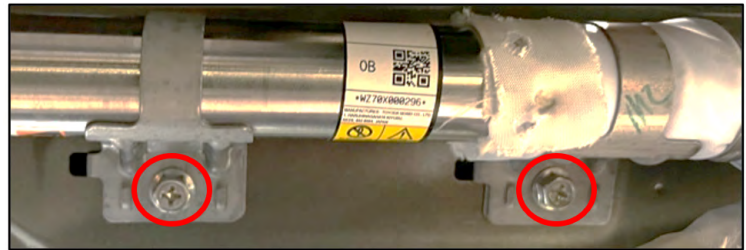
**STEP 5:** Inspect the affected air bag curtain bolts for looseness and the mounting bracket for any signs of play. If looseness is found proceed to **STEP 7**. If no looseness is found, remove the affected curtain air bag inflator bolts then proceed to **STEP 6**.
