# TECHNICAL SERVICE BULLETIN

## Rubber Seal Loose Between Spoiler Support And Liftgate

**23-2237**  
27 September  
2023

Lincoln 2019-2022 Nautilus
-------------------------------

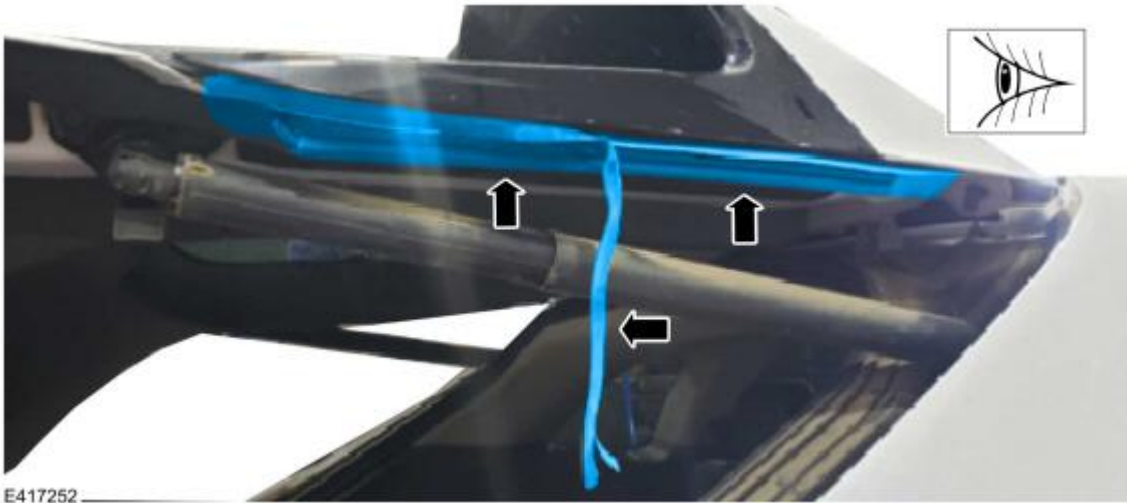
**Issue:** Some 2019-2022 Nautilus vehicles may exhibit the rubber seal between the spoiler support and the liftgate coming loose as shown in Figure 1. This may be due to poor adhesion between the spoiler and the rubber seal. To correct the condition, follow the Service Procedure to replace spoiler support rubber seal.

- 2019-2022 Nautilus
- Loose rubber seal between the spoiler support and the liftgate as shown in Figure 1

1. Remove the spoiler. Refer to Workshop Manual (WSM), Section 501-08 - Exterior Trim and Ornamentation - Removal and Installation - Rear Spoiler.
2. Remove the loose spoiler support rubber seal. (Figure 2)
