## **Battery Electric Vehicle (BEV) - Diagnostic Trouble Code (DTC) C103412, C103413**

Model - VNR-E

Model Years - 2021 to Current

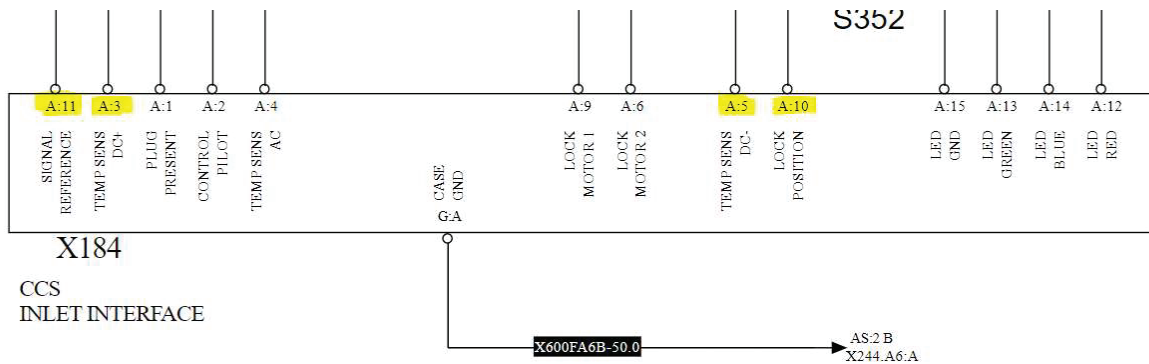
1. Check resistance between pins on CCS connector X184

This condition may be caused by a failed resistor in the Combined Charging System(CCS). Please refer to the troubleshooting steps in the link provided [here](#).

- Notes:
  - \*Be careful when checking resistances to not spread the connector pins\*
  - (A:3 - A:11) & (A:5 - A:11) should be very close to the same value
    - (A:3 – A:5) resistance should be double values above
