TECHNICAL SERVICE BULLETIN

Buzz/Vibration/Rattle From Center Left Of Instrument Panel (IP) During Tip-In - Built On Or Before 01-Jun-2023

23-2301
27 September 2023

Ford 2022-2023 Explorer	Built on or before 01-Jun-2023
----------------------------	--------------------------------

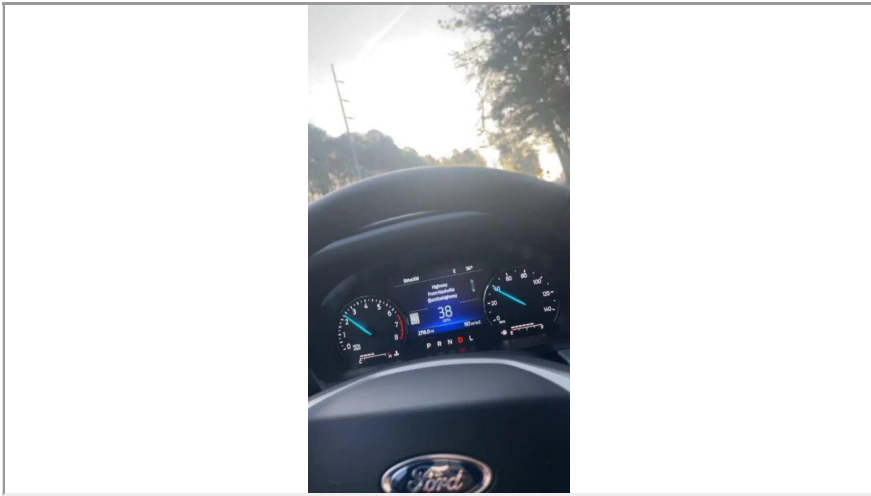
Intermittent Buzz

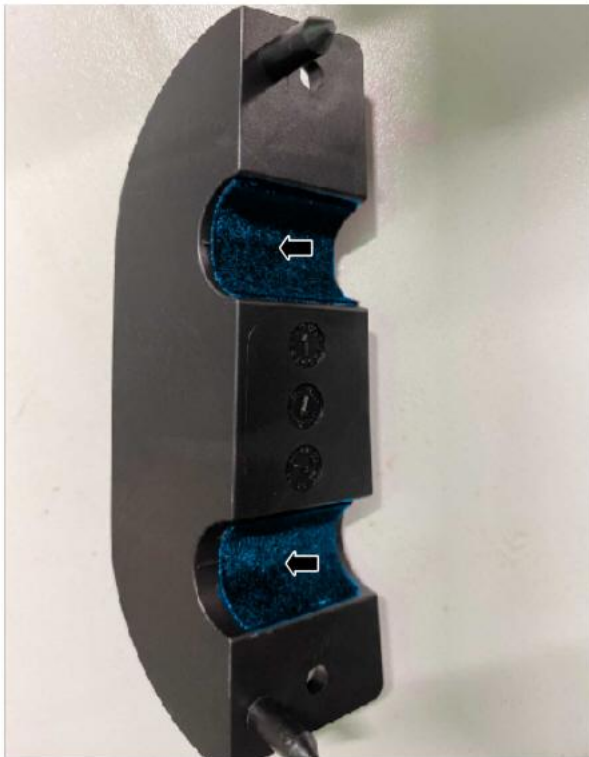
Figure 3

Issue: Some 2022-2023 Explorer vehicles built on or before 01-Jun-2023 may exhibit a buzz/vibration/rattle from the center left of the IP during tip-in when the vehicle is up to operating temperature. This may be due to heater tube movement against the tube bracket. To correct the condition, follow the Service Procedure to apply flock tape to the heater tube bracket.

(3). Apply flock tape from the Rotunda Squeak And Rattle Kit to the left heater tube bracket in the saddle area that clamps the heater tubes. (Figure 3)
