Technical Service Bulletin

Subject: FRONT AND REAR BRAKE NOISE	Bulletin No.: 04-001/23
	Last Issued : 09/13/2023

2013-~~2024~~ CX-5

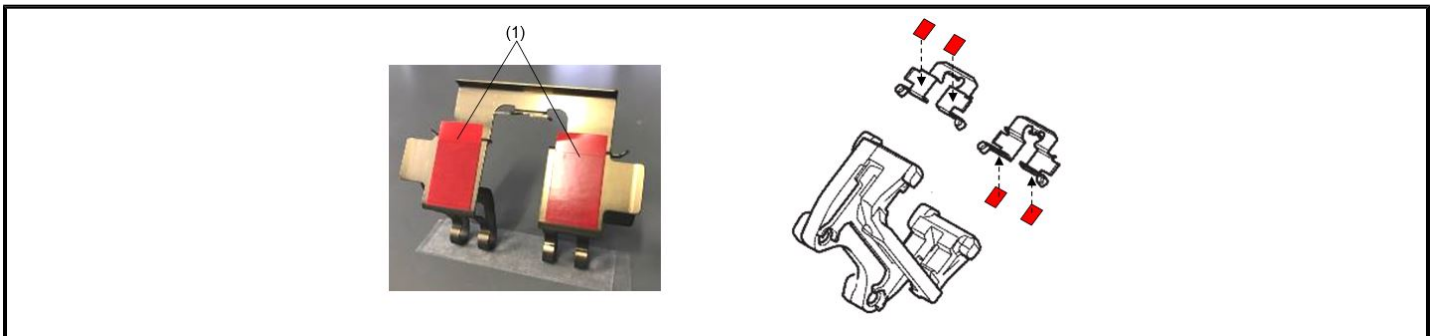
Rear Brake Noise Symptom 1: Some vehicles may exhibit a squeak noise from the rear brakes while braking lightly and occurs more frequently when driving at slow speeds. The noise is caused by poor contact between the guide plate and the mounting support. To eliminate this concern, the material of the pads has been changed to copper-free and the specification of the shims has been changed to a coated spring with tape.

- Verify if the tape is installed to both guide plates (some kits do not have the tape installed and is packaged separately).
- If the tape is not applied to the guide plates, peel off the red release film (1) and the dual adhesive tape (2) from the release paper (3) and apply the dual adhesive tape to the contact surfaces of the guide plates as shown below.
