Technical Service Bulletin

Subject: REAR BRAKE NOISE	Bulletin No.: 04-002/23
	Last Issued : 09/15/2023

2019-2024 Mazda3 (Japan built)
2019-2024 Mazda3 (Mexico built)
2020-2024 CX-30
2022-2023 MX-30

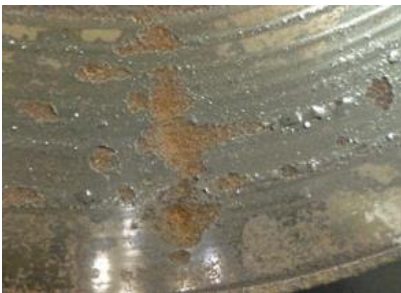
Sample case: if lathe is not applicable.

Some areas of the surface have fallen off due to rust and are too thin.

- Check the disc thickness using a micrometer before lathing, if the thickness is below 8.7 mm for 2WD or 9.7 mm for AWD, replace the disc (DO NOT lathé). Measure the thickness in the relatively less rusted area where the pads are hitting but not in the severely rusted area.
- Disc replacement is acceptable if an on-car lathe machine is not available.
