# Technical Service Bulletin

<b>Subject:</b>  CREAKING NOISE FROM STEERING COLUMN	<b>Bulletin No.:</b> 06-004/23
	<b>Last Issued :</b> 09/07/2023

2016-2023 CX-9 vehicles with VINs lower than JM3 TC\*\*\*\* \*\* 657869 (Produced before Mar. 13, 2023)

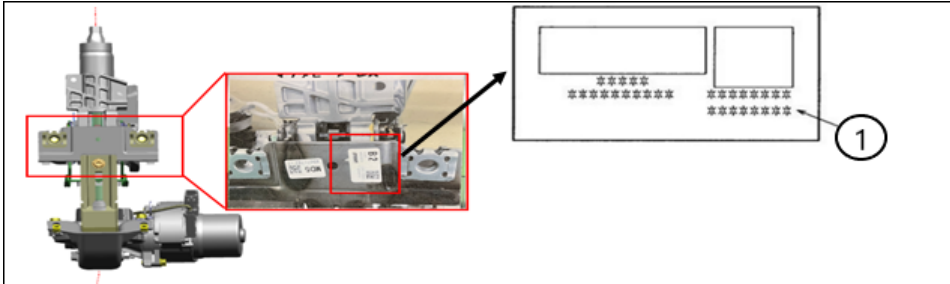
Verify the lot number printed on the sticker (1).

The first digit indicates the year of the production date, the second is the month, the third and the fourth are the day.

**NOTE:** From January to September, the months are represented with their correspondent number (from 1 to 9). The remaining months are represented by a letter (October=X, November=Y, December=Z).

**NOTE:** Before replacing the steering column assembly, refer to the table below and check that the new part lot number is within the indicated production date range.
