Subject: POWER LIFTGATE (PLG) CANNOT BE OPERATED WHILE STUCK IN A PARTIALLY LATCHED OR FULLY OPENED/CLOSED POSITION	Bulletin No.: 09-031/23
	Last Issued : 09/15/2023

2024 CX-90 (with Power Liftgate) with VINS lower than JM3KK*****126418 (produced before August 2, 2023)

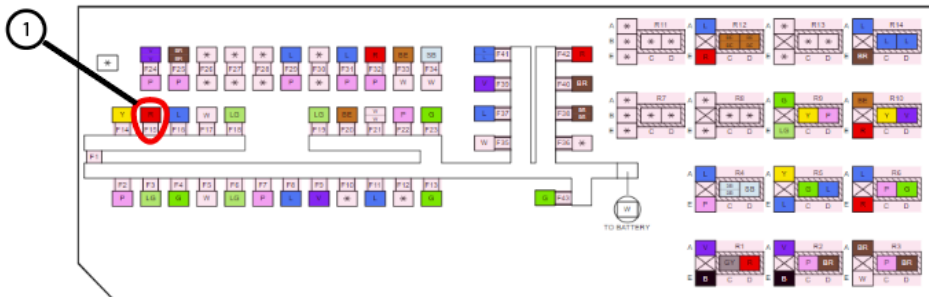
Some vehicles may exhibit that the power liftgate cannot be opened while stuck in an partially latched or fully opened/closed position. This may be caused by improper control software of the power liftgate control module. To eliminate this concern, the control software of the power liftgate control module has been modified.

1. Verify the customer concern.
2. Remove the F15-fuse (1) from the driver's side underhood fuse block (F-01) for at least 30 seconds and then reinstall to reset the power tailgate.
