Technical Service Bulletin

Subject: FRONT DOOR INTERFERES WITH REAR DOOR GARNISH (MAZDA3 5-DOOR HATCHBACK)	Bulletin No.: 09-033/23
	Last Issued : 09/26/2023

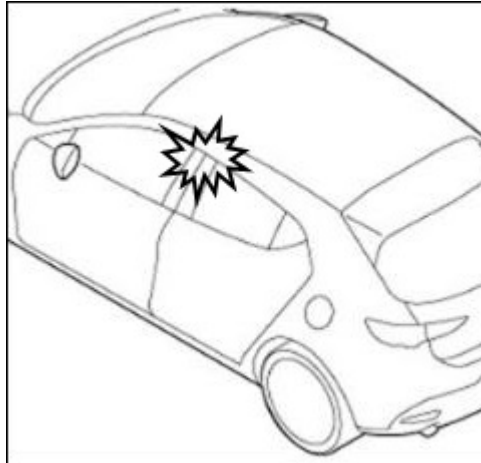
Some vehicles may exhibit that the glass run channel of the front door interferes with the rear door garnish.

Since the front door glass run channel is not fixed to the door strongly enough for the following situations, cycles of door operation may result in interference and lead to damage on the seal rubber at the rear door.

- When the front door glass is closed, the glass run channel may be forced to move to the B pillar side.
- In very hot climates, the glass run channel may expand to the B pillar side.

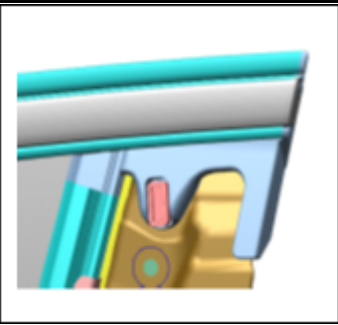
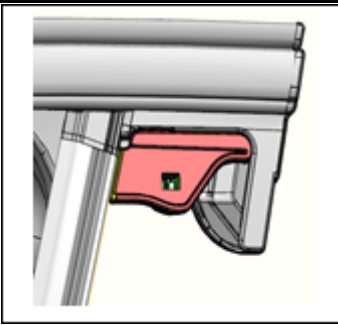
Old	New
Clip

- Phase 1
 - Adhesive has been added between the front door glass run channel and the door panel.
- Phase 2
 - The shape of the front door glass run channel has been changed so as not to make contact with the rear garnish.
 - The shape of the clip at the rear side of the front door glass run channel has been changed for stronger fixing and the hole at the **door sheet metal panel** has been changed accordingly.

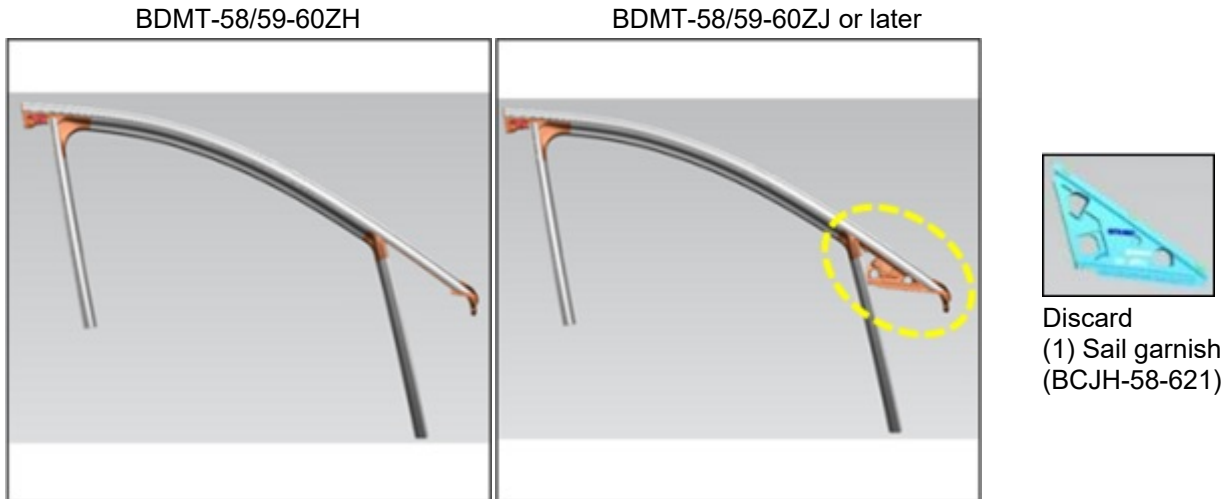
Front door glass run channel and sail garnish are integrally formed

- If the front door glass run channel obtained is BDMT-58/59-60ZJ or later level, remove and discard the sail garnish (1), which is originally installed on the vehicle according to the instructions on MGSS (SAIL GARNISH REMOVAL/INSTALLATION), before installing the front door glass run channel.
