## Checking Surface Wear on the Front Brake Caliper Connection Hose

Multistrada 1200 MY 2010-2014 (all versions)

Service Repair Bulletin SRV-SRB-23-040

Date: September 15, 2023

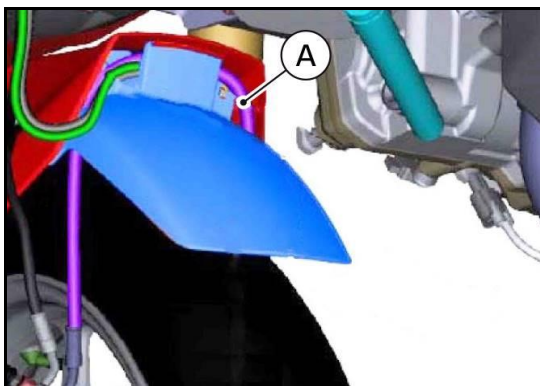
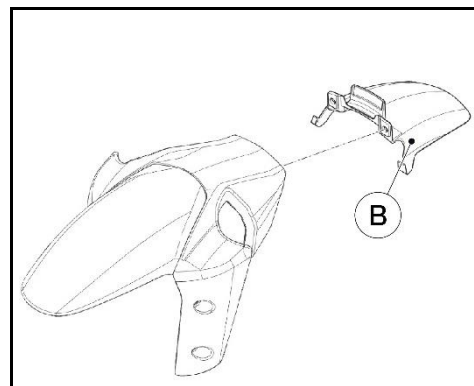
We have received some reports of front brake hose surface wear. After careful analysis of these cases, we found the wear was caused by incorrect repositioning of hoses. For example, after tire replacement procedures or when the front mud guard is removed.

Due to possible unknown service history of the vehicles listed above, we ask you, on all models in question, during each Annual Service and Oil Service, to check the surface wear status of the sheath on **Brake Hose (A) connecting the front brake calipers**.

We also ask you to pay special attention during positioning of the above-mentioned brake hose during all the operations involving removal and subsequent refitting of **Front Mudguard Extension (B)**. For any further details about the assembly instructions of the extension, refer to the specific bulletin [SRV-SRB-19-027](#) ([link ↗](#)).

If wear is found, the hose in question must be replaced.

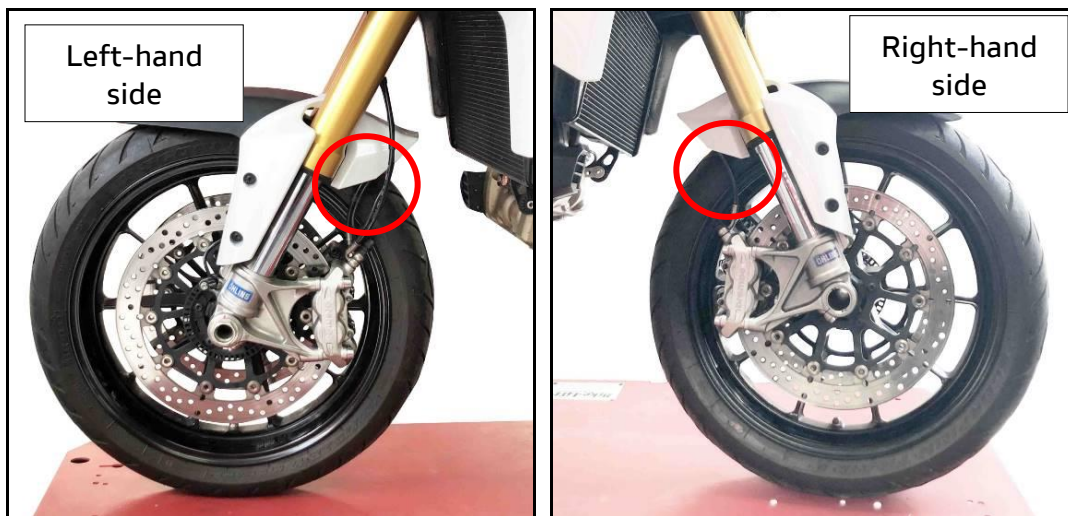
The additional visual inspection of possible wear on front brake caliper connection hose is required at the two areas shown in the figure:

The visual inspection must be carried out regardless of whether the front mudguard extension is present or not.

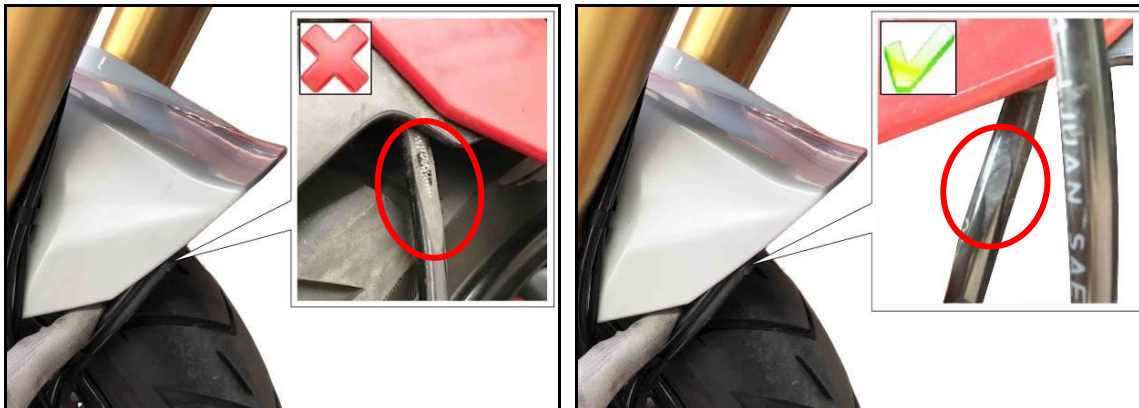
### 1. Vehicle left-hand side

To check for possible wear on the brake hose connecting the front brake calipers, the hose must be moved as shown in the figure:
