**Document ID:** IK1300189

**Title:** HV Enhanced Transfer Case Cooling Up-fit

**Applies To:** HV

This article is to walk through transfer case enhanced cooling up-fit on HV model vehicles equipped with MTC4208/4210 transfer cases

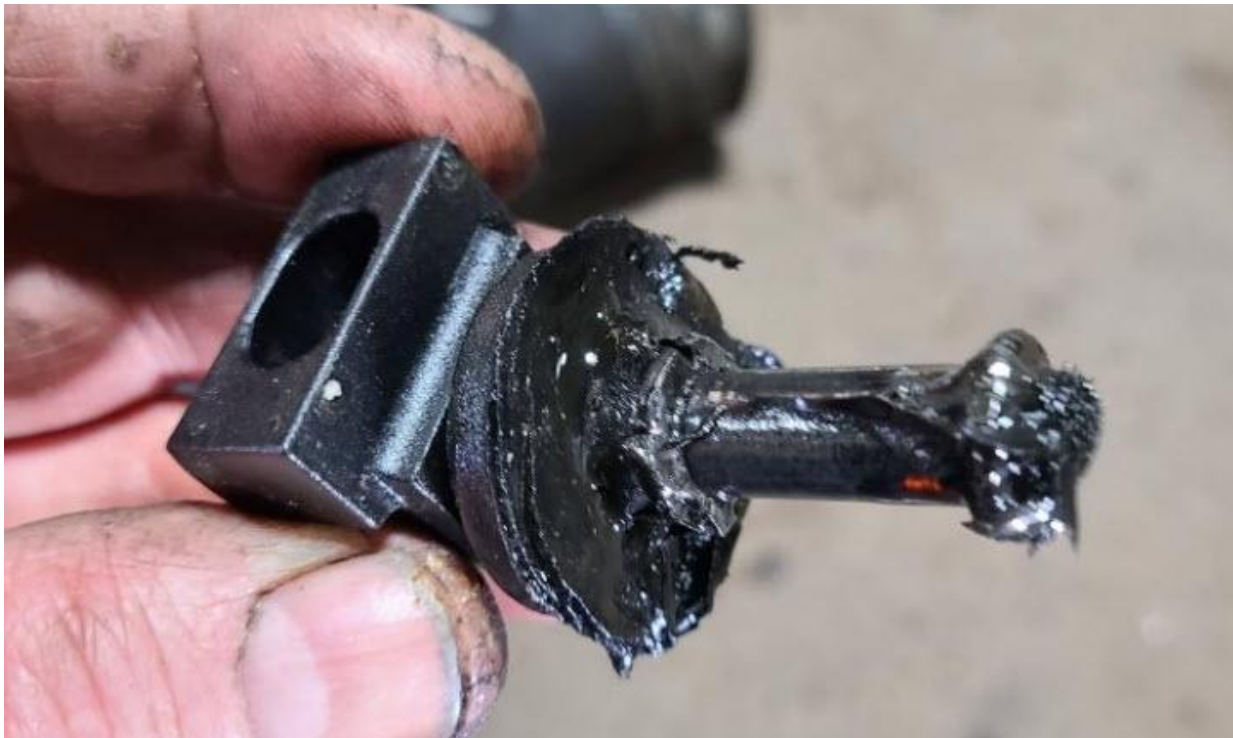
Figure 1 - Melted Speed Sensor

Identify if an overheat condition within the transfer case has occurred (common observation would be an oil leak and/or melted speed sensor as shown in Figure 1 above)

**\*\*\*NOTE\*\*\* Every overheat condition is different, and depending on severity of overheat, a replacement of the transfer case may be required as the internal bearings can be affected. In less severe overheat situations, just a replacement of a speed sensor may suffice**

1. This procedure will require part number KIT2967 to up-fit the XLEV spec transfer case to XLEC spec
2. Follow the attached Meritor procedure (click on the link) - [TRANSFER CASE OPTIMIZED-PERFORMANCE OIL PUMP CONVERSION PROCEDURE](#)
3. Return back to diagnostic steps to identify if a cooler retrofit is also required

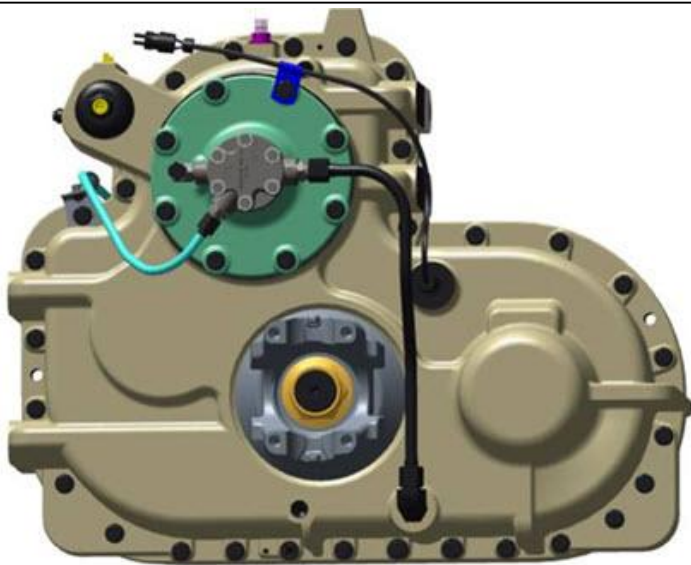
**Figure 2 - EC Spec Transfer Case**

| Step | Action | Decision |
|---|---|---|
| 2 | <b>DIAGNOSTIC:</b><br><br>Using Figure 2 and Figure 3 above, identify if the unit is equipped with an EV or EC Spec Transfer Case (differences in the pump cover)<br><br><b>YES/NO QUESTION?</b><br><br>Is the unit equipped with an EC Spec Transfer Case? | <b>Yes:</b> Continue to Step 3 |
