9YA/9YB - Front Turn Signal/ Auxiliary Headlight Incorrect Operation

Models	Model Year	Model Type	VIN Range	Vehicle-Specific Equipment
Cayenne	2022 - 2023	All	n/a	I-Numbers: 8IT (Basic LED Headlights) & JOB (92 Ah AGM battery)

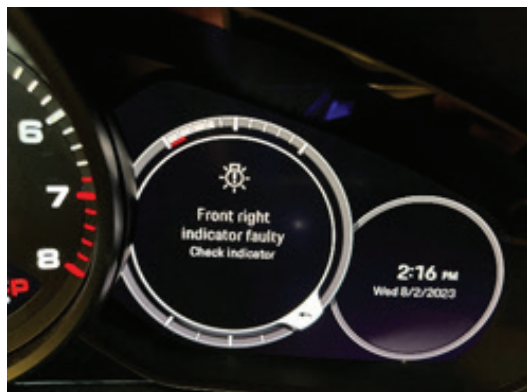
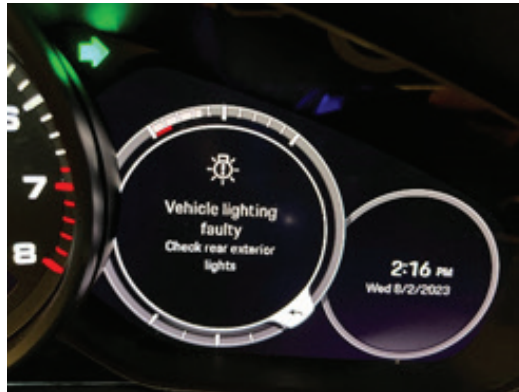
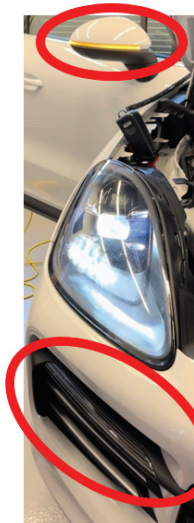
The customer complains of warning(s) in the instrument cluster for "Front (left or right) indicator fault" and possibly "Vehicle lighting fault". Visible symptoms for this concern involve a combination of the turn signal indicator in the instrument cluster rapid blinks and the turn signal stops blinking orange. Fault code "**C11A401 Turn signal bulb, electrical malfunction**" will be present in at least one headlight. Possibly "**B182700 – Feedback, blinking status, impl. Signal**" will also be present. B182700 is a consequential fault in the rear BCM.

Due to the software diagnostics of the front exterior lighting system, when vehicle voltage is low enough (instrument cluster displaying voltage at 11.9V or lower), operating the turn signals will cause the faults and conditions described to occur. These conditions can be presented in a key-on/engine-off state, or while start-stop is engaged.

Test and verify the 12V AGM battery is healthy and able to maintain a charge.

The temporary solution for this issue is to replace the basic LED headlights with the upgraded PDLs headlights option (**not PDLs+**).
