WIND/TAPPING NOISE FROM EXTERIOR A-PILLAR/WINDSHIELD AREA AT MOTORWAY SPEEDS

Defender

- 22–23MY Defender

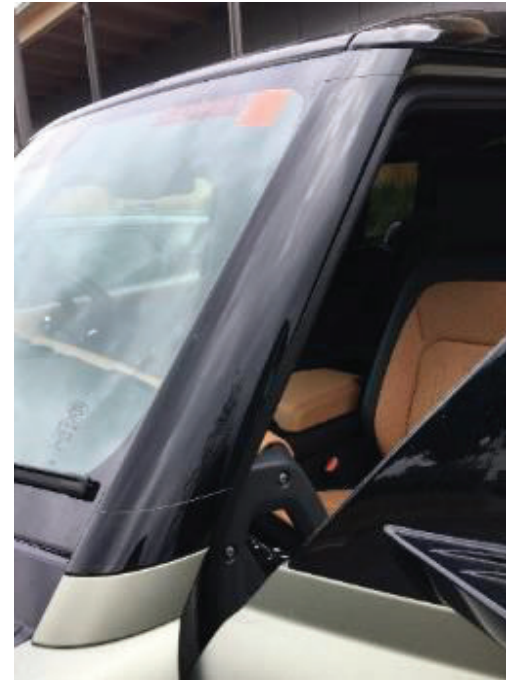
- There may be a noise concern where the exterior windshield trim contacts the windshield.
