CAMPAIGN BULLETIN

Seat Frame Weld

Reference: PC987

PC987 – 2023-2024 PATHFINDER, ROGUE FRONT POWER SEAT FRAME WELD

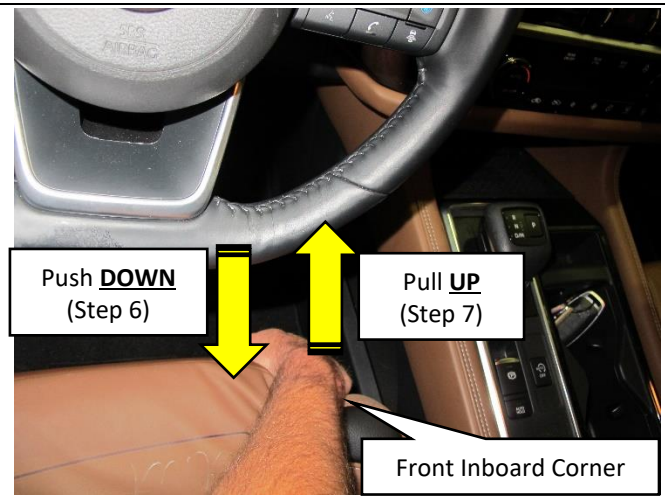
Figure 7

7. Pull up at the J-clip location specified in Figures 6 and 7 (front inboard corner).

- If the front inboard corner of the seat **moves up**, use the tape measure as reference to measure the amount of **up** travel
- Document the amount of **up** travel in inches on the Repair Order for the driver's seat

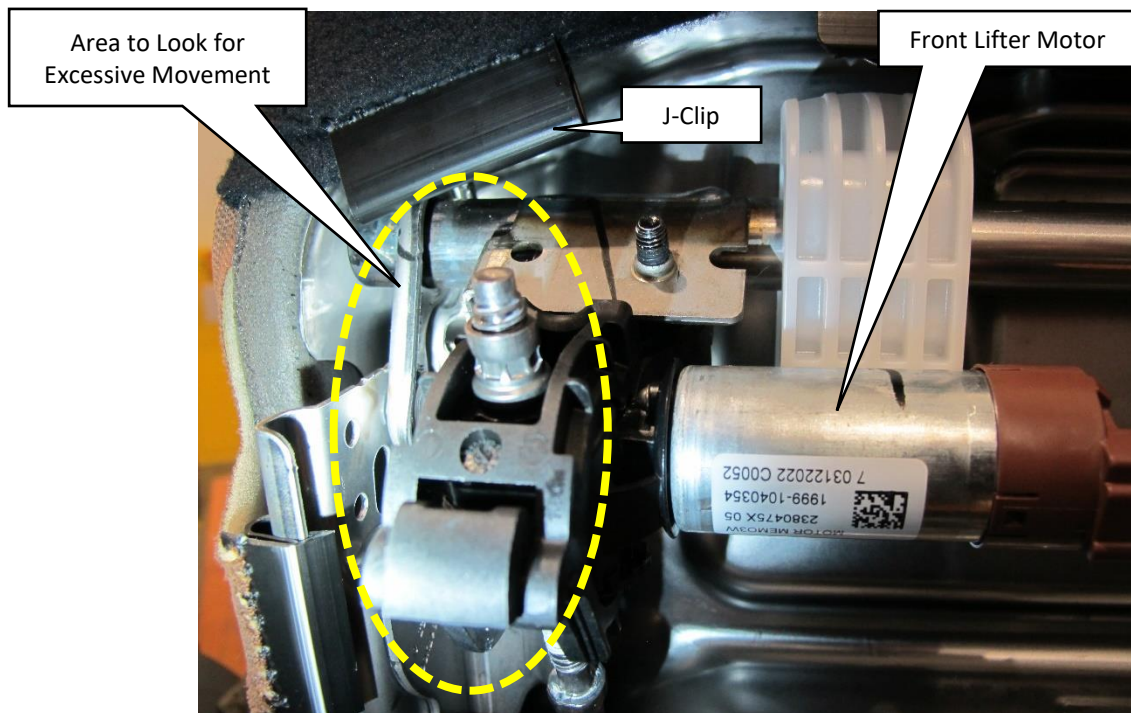
Figure 8

HINT: Any excessive up movement can be observed under the seat at the front the lifter motor area, refer to Figure 8.

9. Using the tape measure for reference, did the front inboard corner of either power front seat frame **move up** more than 1 ½ inches?

- **YES** = Replace the affected front power seat cushion frame assembly per the Electronic Service Manual (ESM): **BODY INTERIOR-SEAT-UNIT DISASSEMBLY AND ASSEMBLY-FRONT SEAT-SEAT CUSHION-Seat Cushion.** Make sure to follow all ESM warnings and cautions.
- **NO** = No further action is required, refer to CLAIMS INFORMATION section submit a claim for the inspection.
