CAMPAIGN BULLETIN Seat Frame Weld

Reference: PC988

Date: September 15, 2023

PC988 – 2024 QX60 FRONT POWER SEAT FRAME WELD

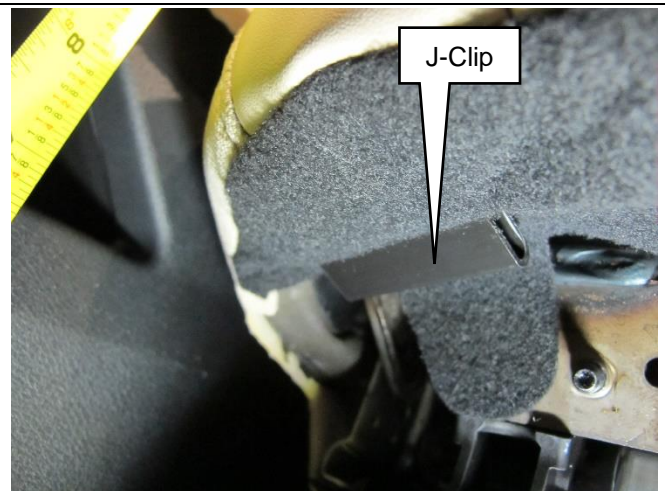
Figure 6

4. Locate the J-Clip under the front inboard corner of the seat (Figure 6).

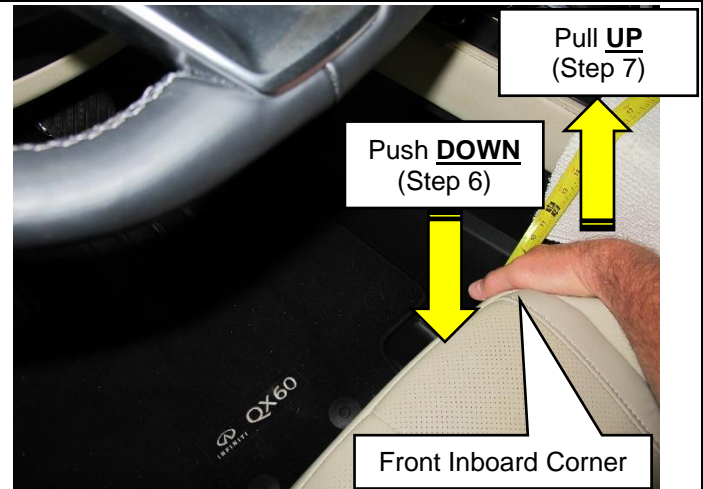
Figure 7

5. Without sitting in the driver seat, position your right hand under the front inboard corner (center console side) at the J-clip location shown in Figure 7.

6. Push down on the front inboard corner of the seat (Figure 7).
7. Pull up at the J-clip location specified in Figures 6 and 7 (front inboard corner).
- If the front inboard corner of the seat **moves up**, use the tape measure as reference to measure the amount of **up** travel
 - Document the amount of **up** travel in inches on the Repair Order for the driver's seat

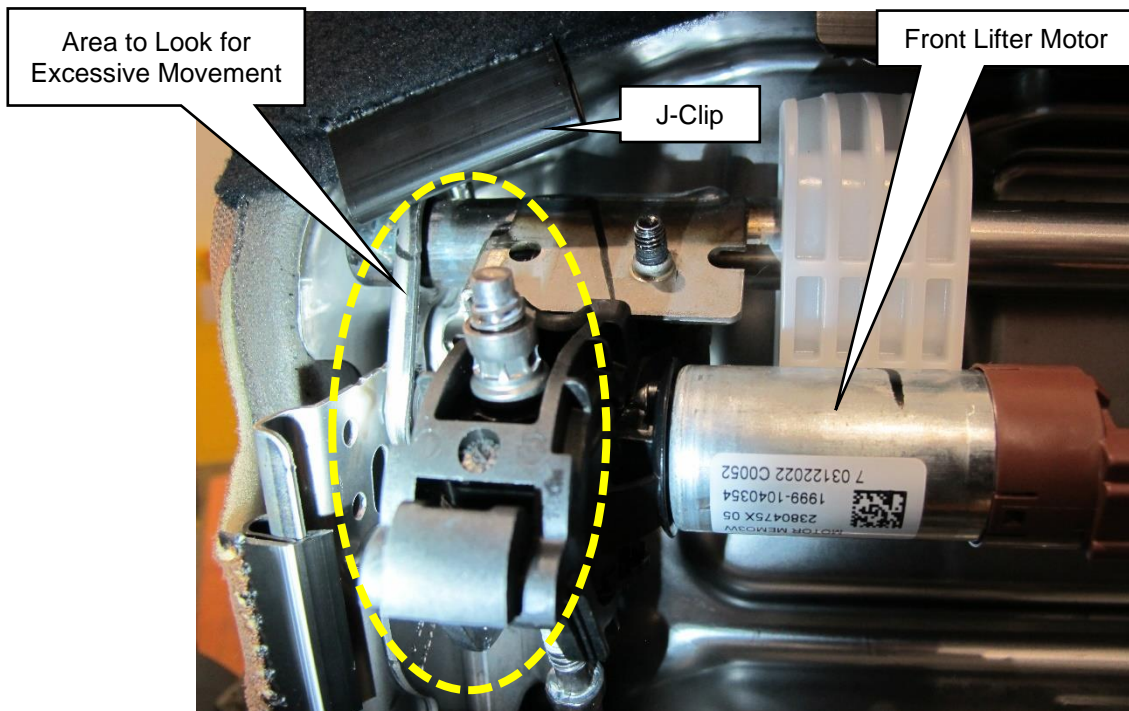
Figure 8

HINT: Any excessive up movement can be observed under the seat at the front the lifter motor area, refer to Figure 8.

9. Using the tape measure for reference, did the front inboard corner of either power front seat frame **move up** more than 1 ½ inches?

- **YES** = Replace the affected front power seat cushion frame assembly per the Electronic Service Manual (ESM): **BODY INTERIOR-SEAT-UNIT DISASSEMBLY AND ASSEMBLY-FRONT SEAT-SEAT CUSHION-Seat Cushion.** Make sure to follow all ESM warnings and cautions.
- **NO** = No further action is required, refer to CLAIMS INFORMATION section submit a claim for the inspection.
