# McLaren Speedtail – Filler Flap Operation Enhancement

| <b>Campaign reference:</b> | SCB 23 A 001 |
| <b>Situation:</b> | Replacement of the fuel and oil flap push-push mechanism rubber caps with new plastic version |
| <b>Date:</b> | 14 September 2023 |

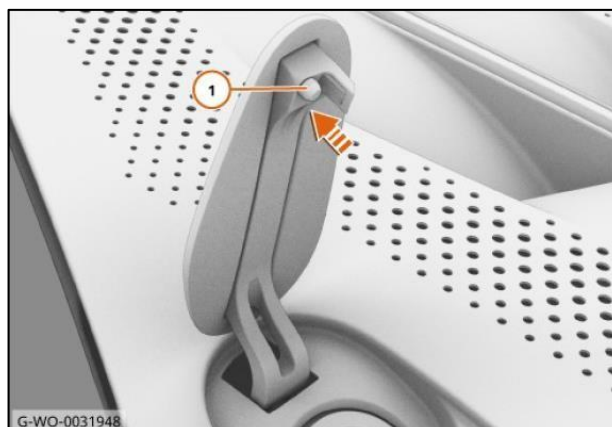
Through continuous product quality monitoring, McLaren Automotive has identified that the rubber caps of both the filler flap mechanisms can deform over time and prevent them from opening. To address this, McLaren Automotive, has released a solution which includes a new plastic cap which needs to be fitted to each of the fuel and oil filler flaps in place of the old caps.

**Image 1:** Location of the filler flap plastic cap

The below part is required to action this rework and can be ordered in the usual way via Unidial 2. Two new caps are required per vehicle. One of each to be fitted to the fuel and oil filler flaps.

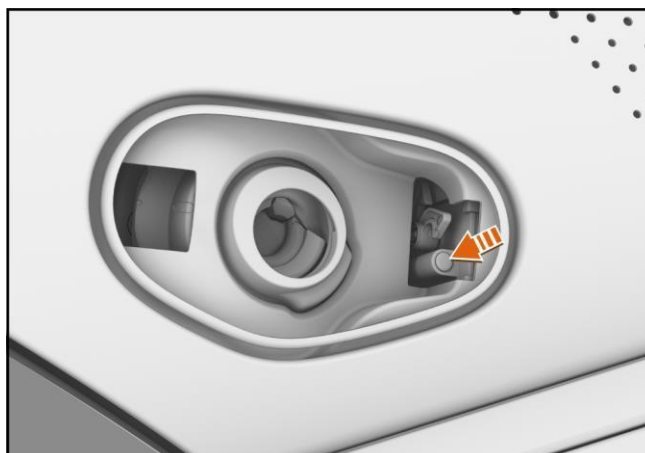
**Image 2** Filler Flap Actuator Shaft

As an additional rework care point, after completion of the plastic caps installation, technicians must visually inspect and clean both filler flap actuator shafts to remove any debris or dirt present.
