September 28, 2023

Version 2

Clunking or Looseness in the Outer Tie Rod

Supersedes 23-019, dated May 4, 2023, to revise the information highlighted in **yellow**.

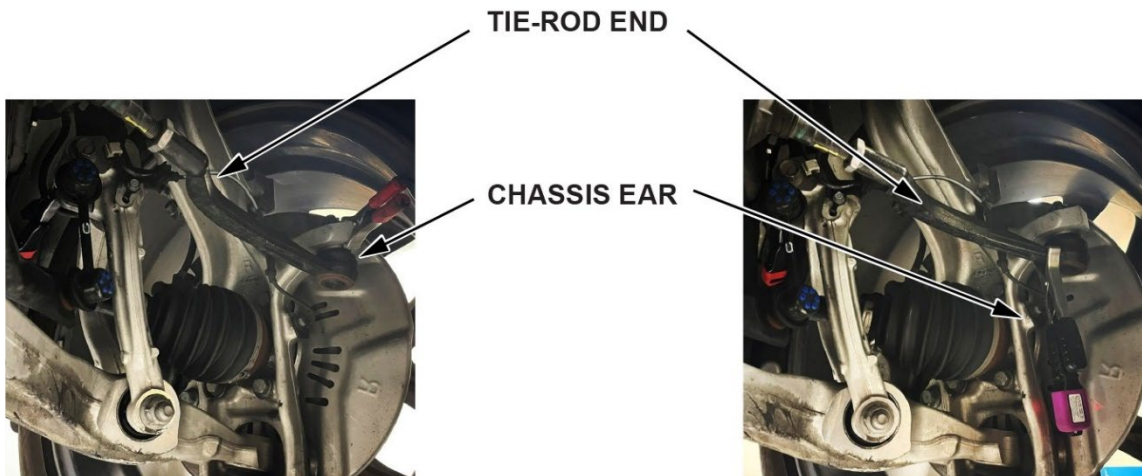
1. Install a chassis ear near the tie-rod end and on other suspected areas around the suspension. Test drive the vehicle to determine the following driving conditions of the noise:
 - If the noise is being caused when turning left or right, and isolated to the tie-rod with the chassis ear, then continue to the **next step**.
 - If the noise is caused by another driving condition (for example: going over bumps or driving over potholes), this bulletin does not apply. Continue with **normal troubleshooting**.

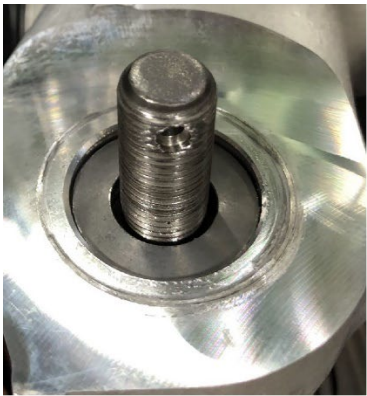
**SAMPLE IMAGE OF
GOOD CLEAN SURFACE**

1. With the vehicle raised, remove the front wheel from the side that will need repair.
2. Remove the loose outer tie-rod cotter pin and nut.
3. Clean the mating surfaces with compressed air before reinstalling. Those surfaces should be smooth and free from any debris.

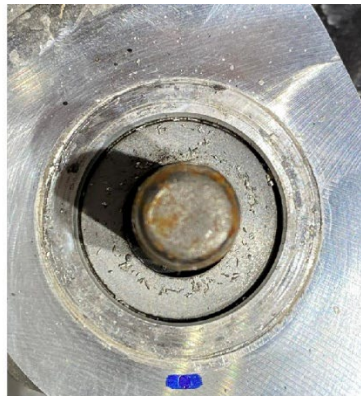
**SAMPLE IMAGE OF
SURFACE WITH DEBRIS**
