Service Bulletin

Bulletin No.: 22-NA-095

Subject: Front Brake Squeal Noise Heard During Light Brake Pedal Application

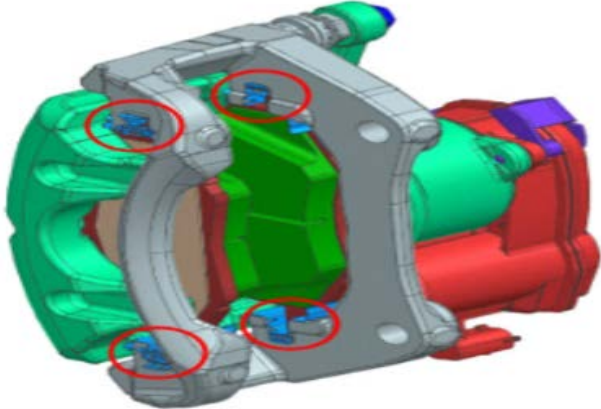
6077243

Note: There are 4 Pad abutments per caliper.

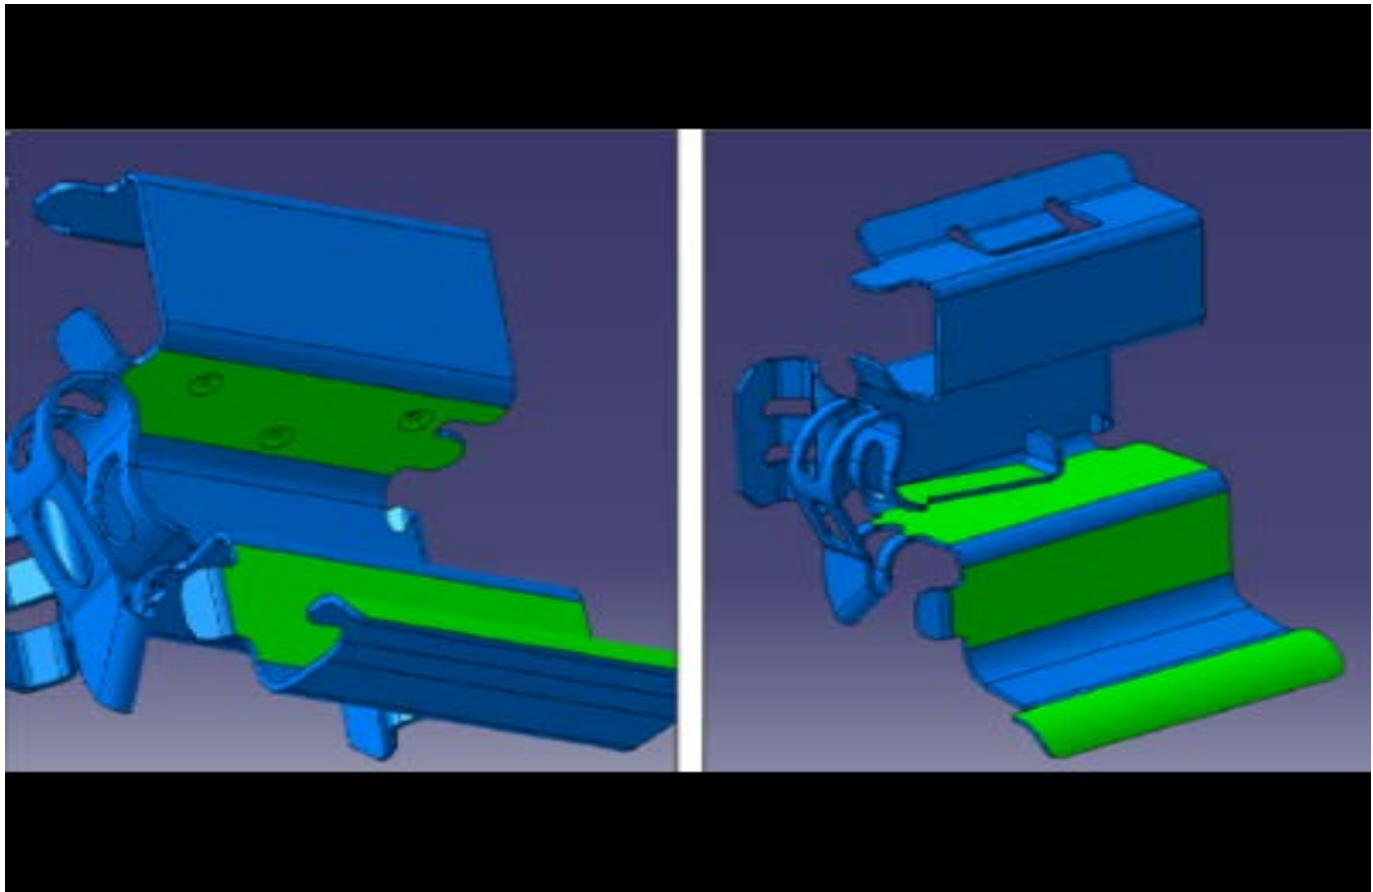
6077247

Note: The green area shown above designates the required grease positions.

- Clean the pad spring abutment area on the caliper and anti-rattle clip.

Note: The recommended grease volume is about 1.1 g per caliper.

- Apply Molykote M-77 Grease (GM P/N 19356408) on caliper pad spring abutment and clip as shown in the graphic above.
- Then reinstall the existing pads. Refer to *Front Disc Brake Pads Replacement* in the Service Manual.
- Verify brake noise has been eliminated.

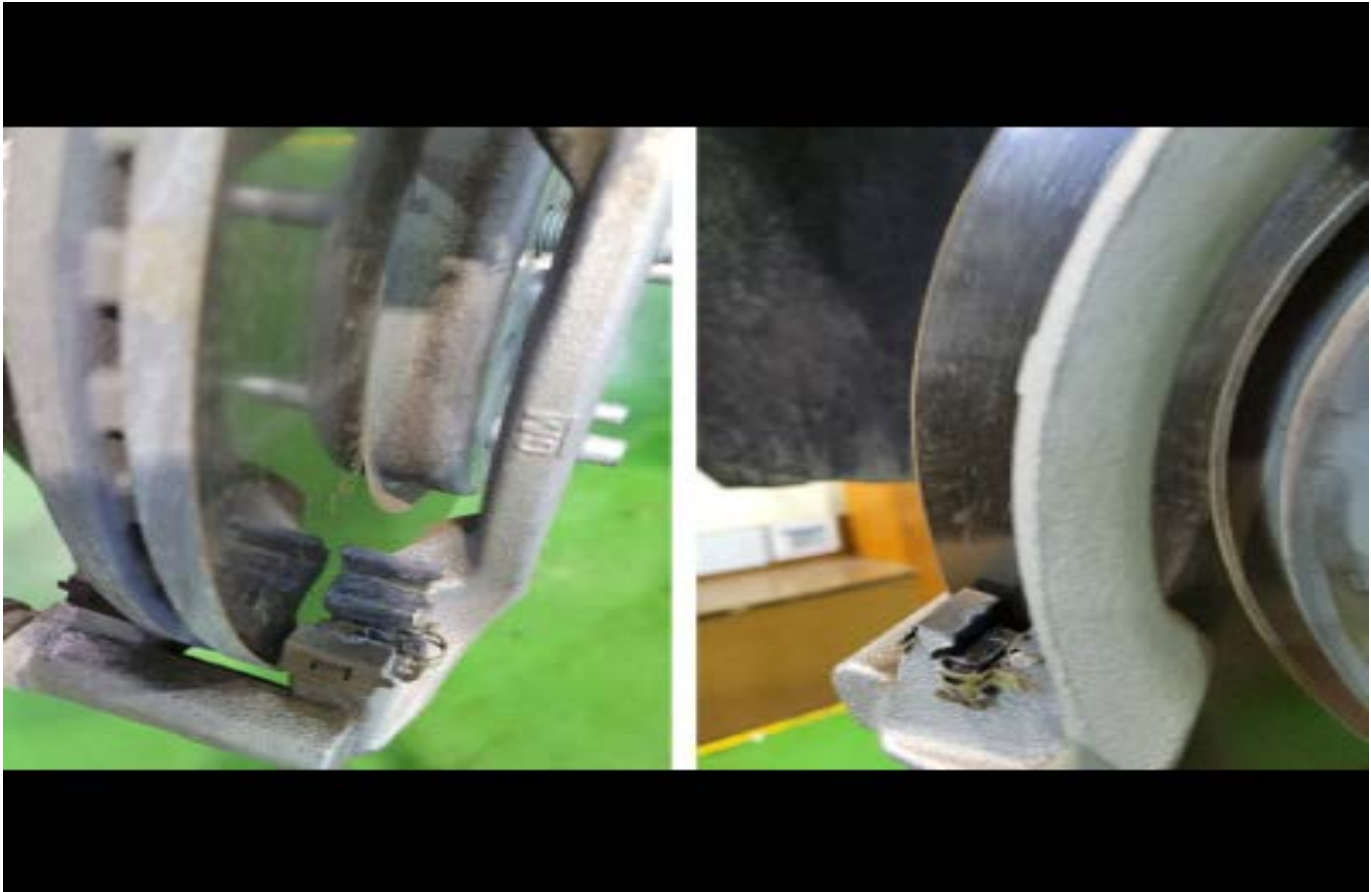
6077250

Note: The above graphics are actual grease adding examples.
