# Service Bulletin

Bulletin No.: 23-NA-142

**Subject: No Forward Gear When Shifting from Park to Drive and/or Reverse to Drive**

Brand:	Model:	Model Year:		VIN:		Engine:	Transmission:
		from	to	from	to		
Chevrolet	Express	2017	2023				6L90 (MYD)
GMC	Savana

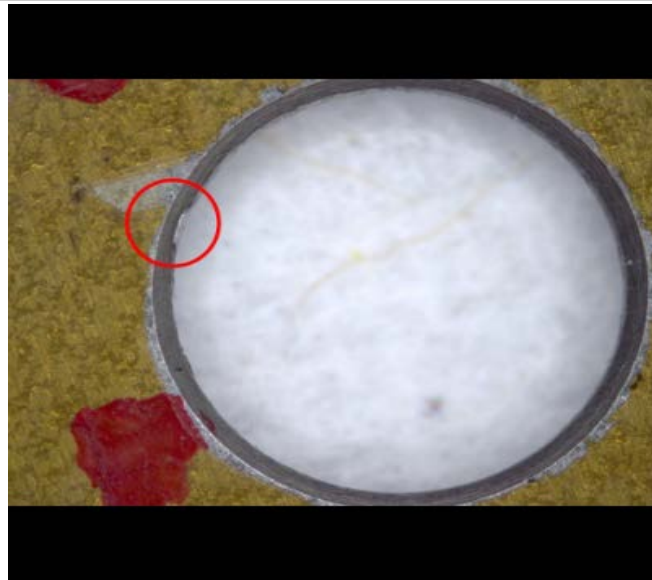
6404809

- The seat for the check ball is out of spec relative to coin depth. This potentially can cause burrs, dents, or dings, which could cause the plastic check ball to wear prematurely.

- The #1 check ball has a high duty cycle and when combined with the issue, there is a possibility for the check ball to wear and then become stuck or pass through the spacer plate.

Replace the spacer plate and check ball.

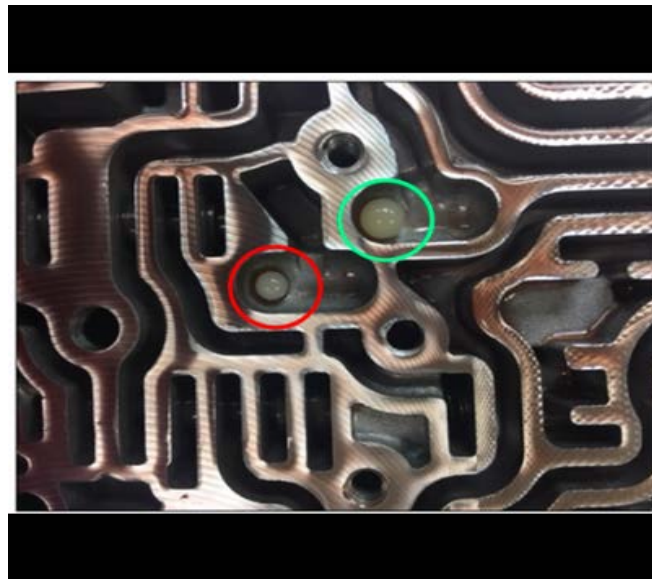
6404322

- As indicated in the graphic above, the check ball circled in RED has prematurely worn down. It should be the same diameter as the check ball circled in GREEN.
