GROUP	MODEL
ELE	2020-2023MY Multiple Models w/ AVN5W
NUMBER	DATE
314	October 2023

## TECHNICAL SERVICE BULLETIN

### SUBJECT: UNEVEN/SLIPPERY ROAD WARNING DISPLAYED ON INSTRUMENT CLUSTER

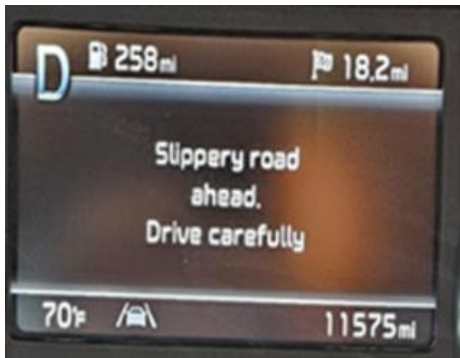
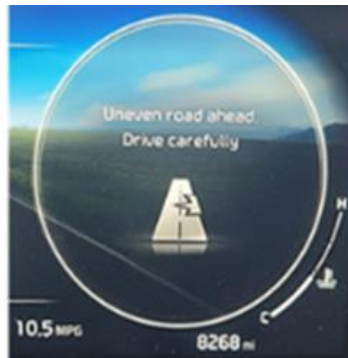
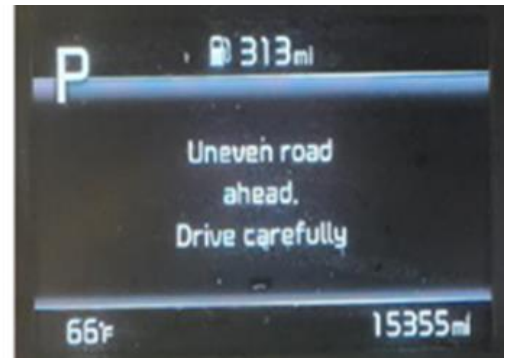
This bulletin provides information to update the software on 5<sup>th</sup> Generation AVN wide on certain 2020-2023MY Kia vehicles (refer to model list on page 3) to remedy a warning sound accompanied by a 'Slippery road ahead. Drive carefully' or 'Uneven road ahead. Drive carefully' warning which is displayed on the instrument cluster. The current AVN software causes the warning sound and message to repeat approximately every ten (10) seconds, if the vehicle is not in motion, in 'PARK' or driving on even surfaces. Follow the procedure outlined in this publication to update the software on 5<sup>th</sup> Generation AVN wide units using the applicable USB Flash Drive A or B for the applicable vehicle.
