Technical Service Bulletin

35 Gearbox Malfunction Warning, DTC P0C2900, P176F00, P176E00, P175E00, P175D00, P189900, P060700, P081000 in the TCM

35 23 46 2050723/4 October 9, 2023. Supersedes Technical Service Bulletin Group 35 number 23-43 dated August 2, 2023, for reasons listed below.

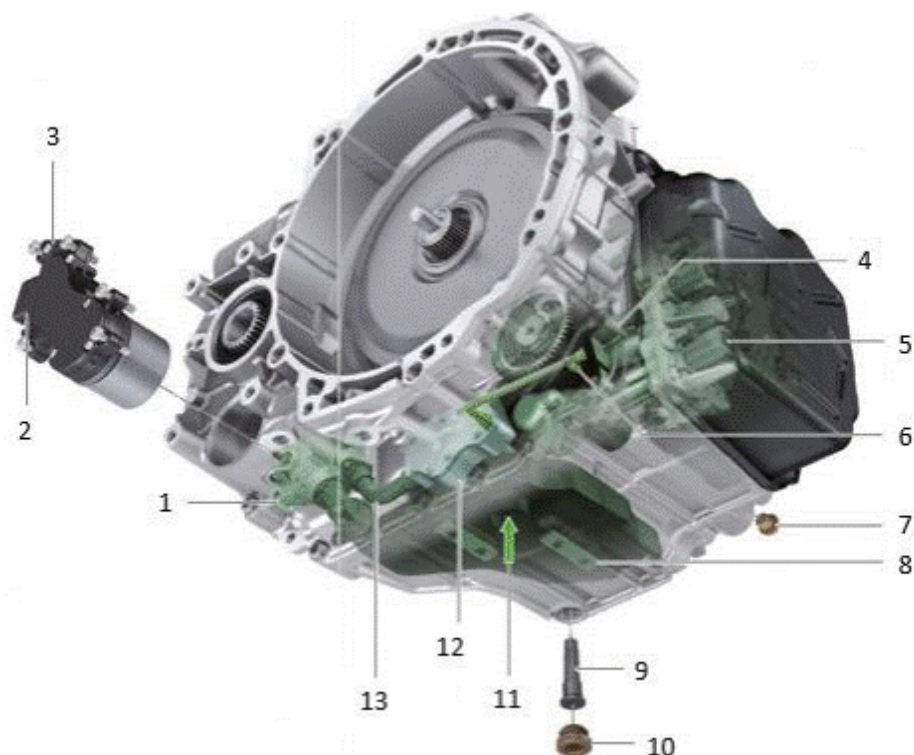
Figure 1. 0GC Gearbox Components.

Component related issue of auxiliary hydraulic pump (Figure 1).

Item 1: auxiliary hydraulic pump 1 for gearbox oil (V475)

Item 2: electrical connection for auxiliary hydraulic pump 1 for gearbox oil (V475)

Item 3: electric motor for auxiliary hydraulic pump 1 for gearbox oil (V475)

Item 4: main ATF pump

Improved auxiliary hydraulic pump in production.

Replace the auxiliary hydraulic pump according to the instructions attached to this TSB (Figure 3), and the parts information listed below. The event memory of the gearbox electronics (diagnostic address 002) must then be erased according to the attached instructions.

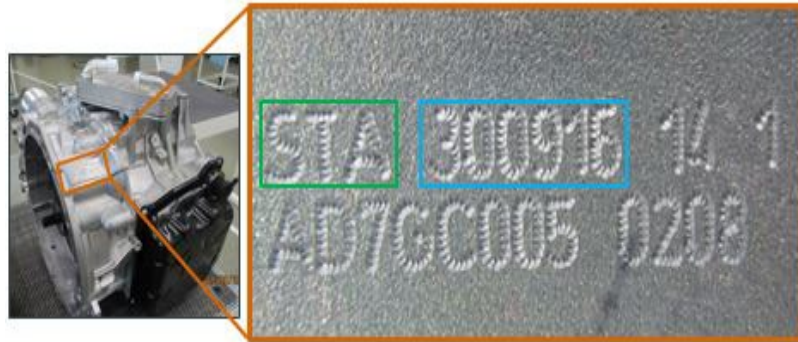
Figure 2: Transmission identification example.

Gearbox code: STA (green box).

Gearbox Production date: **300916** = **03.09.2016** (blue box).

Date format: Day/Month/Year

- If the gearbox production date is after 26.09.2017, this TSB does not apply. Proceed according to Guided Fault Finding. Please note that in this case, the costs for the repair cannot be billed under this TSB.
- If the gearbox production date is on or before 26.09.2017, continue as described below.
