91 PSS: ConBox: Bluetooth inop / grayed out, Audi connect features inop, antenna malfunction, SOS malfunction

91 23 32 2071693/1 October 9, 2023.

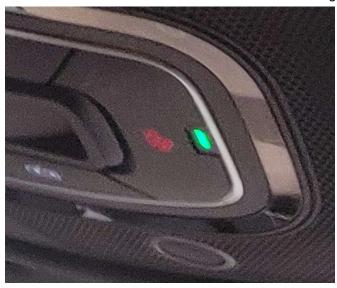
The e-Call LED in the roof module remains illuminated green at all times (see Figure 3).

Figure 3: e-Call LED illuminated green.
