# Technical Service Bulletin

## 92 Repairing corrugated hose for windshield washer system

92 23 37 2065963/2 October 2, 2023. Supersedes Technical Service Bulletin Group 92 number 22-28 dated February 8, 2022 for reasons listed below.

Model(s)	Year	VIN Range	Vehicle-Specific Equipment
All Audi Vehicles	2019 – 2025	All	Not Applicable

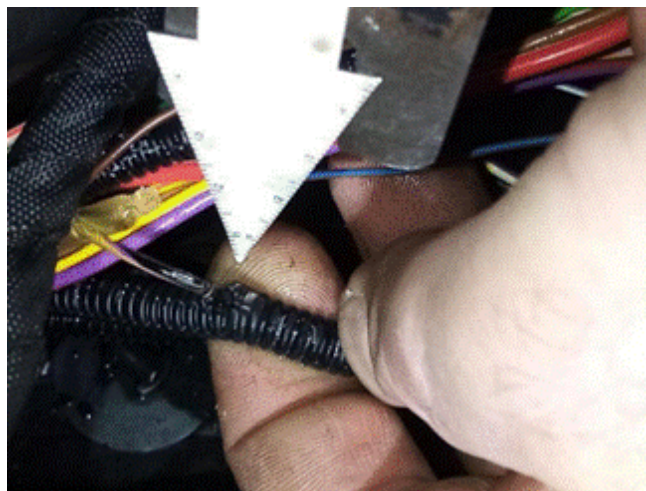
A windshield washer solvent leak has developed in the corrugated windshield washer hose inside the cabin, specifically the hose that is wrapped among the wiring harness bundle. See figures 1 and 2 for examples of the damage.

**Figure 1.** Rupture in corrugated windshield washer hose accompanied by a wiring abrasion.

1. Before repair, additional information is required. Please take photos clearly showing the damage (at a distance and close-up) and post them to Doc-IT. After this documentation is posted remove a section of the corrugated washer hose that contains the damage 50 mm to each side of the damage. The removed section will then be 100 mm and contain the damaged area. This section will be requested for return to the WPRC to assist us in gathering additional information for the investigation.
2. Elsa describes the repair procedure for ruptured corrugated windshield washer hoses using the following navigation path:

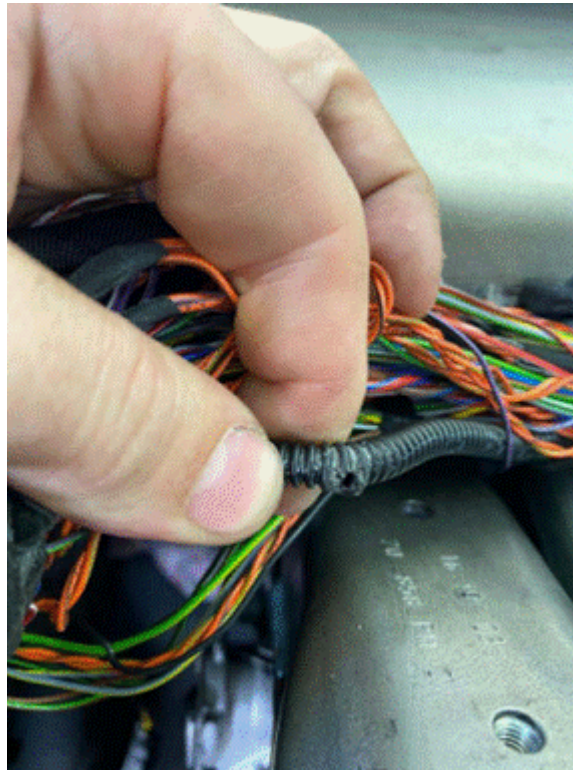
**Figure 2.** Ruptured corrugated windshield washer hose.
