# Service Bulletin

Bulletin No.: 21-NA-120

**Subject: Diagnostic Tip for Noise, Vibration and/or Harshness Issues/Clunk Noise Heard During Coast Down Event**

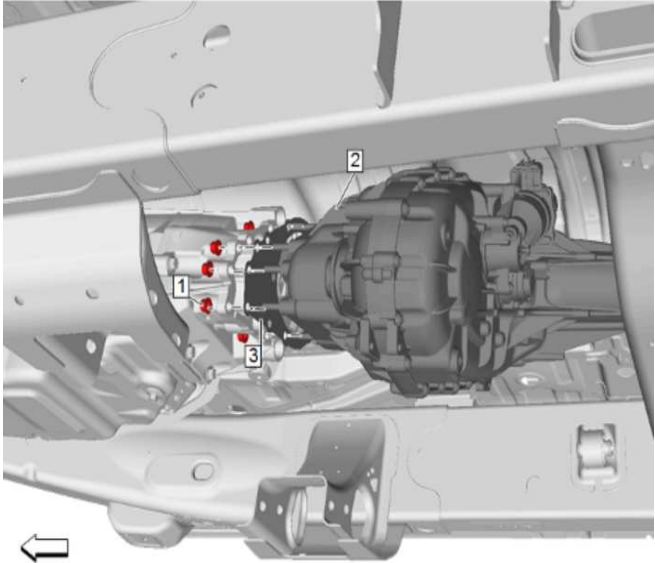
<p><b>Correction</b></p>	<div style="text-align: right; margin-bottom: 10px;">5411622</div>

<b>Involved Region or Country</b>	North America, Middle East, Israel
<b>Additional Options (RPOs)</b>	NQF (TRANSFER CASE-ELECTRIC SHIFT CONT, TWO SPEED, ALUM) NQH (TRANSFER CASE-ACTIVE, TWO SPEED, SWITCH ACTIVATED, ALUM)
<b>Condition</b>	Some technicians or customers may comment on one or more of the following conditions after the transfer case was removed from the transmission and reinstalled during a recent repair: <ul style="list-style-type: none"> <li>• Harsh downshift during a coast down event</li> <li>• Noise during a coast down event</li> <li>• Vibration during a coast down event</li> <li>• Harshness issues such as a clunk noise heard during coast down event</li> </ul>
<b>Cause</b>	This condition may be caused by a misalignment between the transmission output shaft and the transfer case input. ⇒ Transfer case to transmission misalignment could cause the transfer case shift collar to slip out of engagement.

<ol style="list-style-type: none"> <li>1. Connect the GDS Scan Tool and monitor transmission shift data.</li> <li>2. Drive the vehicle and duplicate the condition while monitoring transmission shift data to determine if the noise/clunk/roughness occurs during the downshift or if the noise/clunk/roughness occurs randomly during the de-acceleration event.</li> </ol> <p>⇒ If it is determined that the noise/clunk/roughness does not occur at a transmission downshift, shift point follow published Service Information for Transfer Case Assembly Replacement (with MGM, MGU, MKM Automatic Transmission).</p> <p><b>Note:</b> The transfer case does not need to be completely removed from the vehicle. The attaching bolts must be loosened (not removed) to allow the transfer case to be separated from the transmission a minimum of a ½ (13mm) but no more than 1 inch (25mm). The use of transmission jack or adjustable jack stand may provide support in holding the transfer case to the transmission. Proper transfer case to transmission bolt installation, tightening sequence and proper torque must be followed.</p> <p>If the noise/clunk/roughness is occurring during a transmission downshift, shift point, refer to SI for further diagnostics.</p>
